IBP report HTB-005EN/2023

## Assessment of the long-term reliability of installed external thermal insulation composite systems

Conducted on behalf of  
Verband für Dämmsysteme, Putz und Mörtel e.V.  
Reinhardtstraße 14  
10117 Berlin, Germany

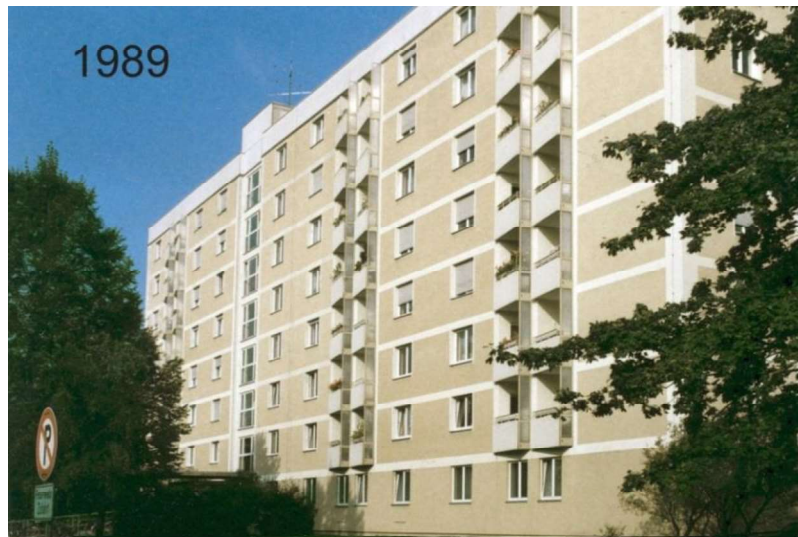
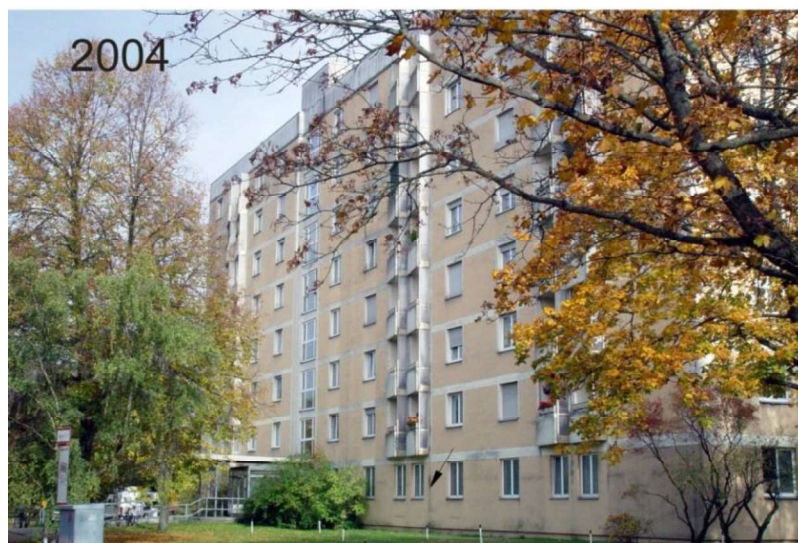
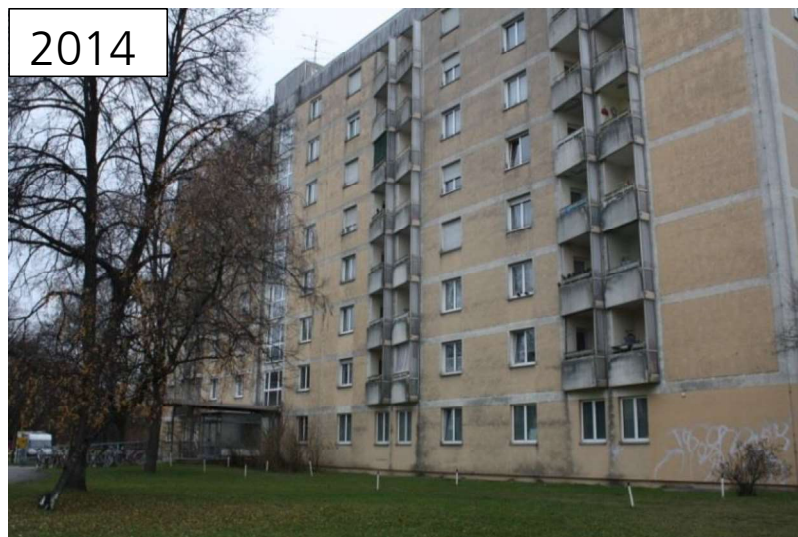
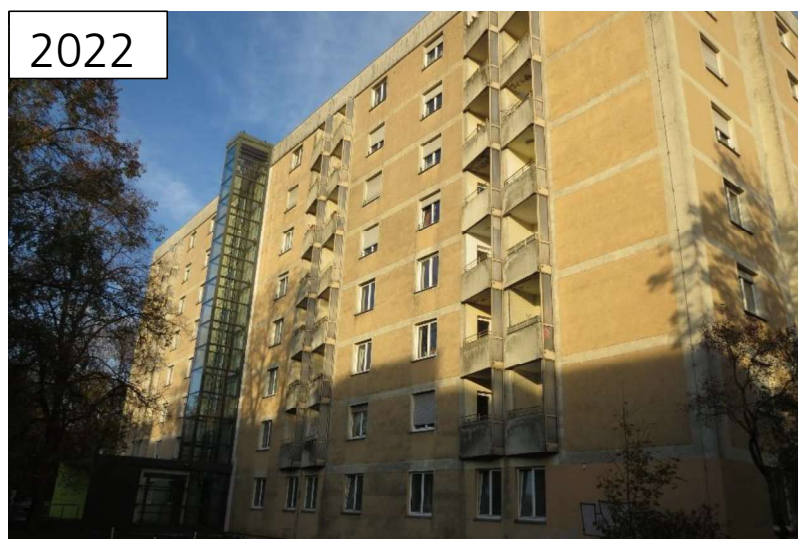
Figure 4 and Figure 5 show the west façade of object 16 (retirement home in Munich). The change in the façade over 33 years can be clearly seen here. The top image shows the façade three years after a 60 mm thick mineral wool insulation was applied (1989). The façade had not been reworked since it was created. In the lower image of Figure 4, some graying and algae formation can already be seen on unprotected wall sections (2004). The upper image of Figure 5 shows the façade condition in 2014, and the lower image shows the condition of the façade today after 33 years. In the meantime, nearly the entire façade has grayed, or the façade color has weathered away. The fastening dowels of the ETIC system are clearly visible (see Figure 6). The high weathering stress on the façade is also indicated by the condition of the balustrades, which show a considerably stronger discoloration than the ETIC system. No significant defects are visible on any of the four façade orientations. No cracks are visible over the surface. This is the oldest assessed building not maintained with functional ETICS, even though it needs renovation from an optical point of view. Overall, the façade has not significantly deteriorated since the last assessment.

Figure 4:  
West facade of object 16 (retirement home in Munich) in 1989 (top), in 2004 (bottom). The different color appearances are solely due to the coloring of the photo.

Figure 5:  
West facade of object 16 (retirement home in Munich) in 2014 (top), in 2022 (bottom). The different color appearances are solely due to the coloring of the photo (weather).

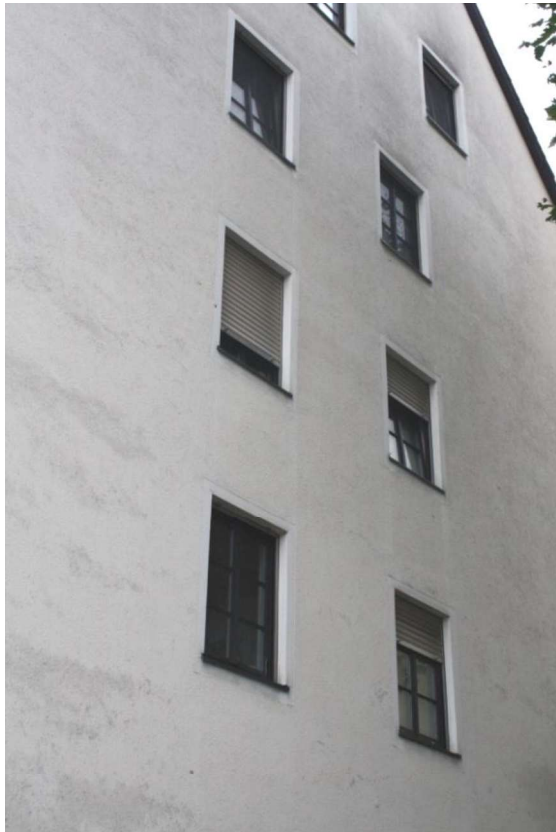
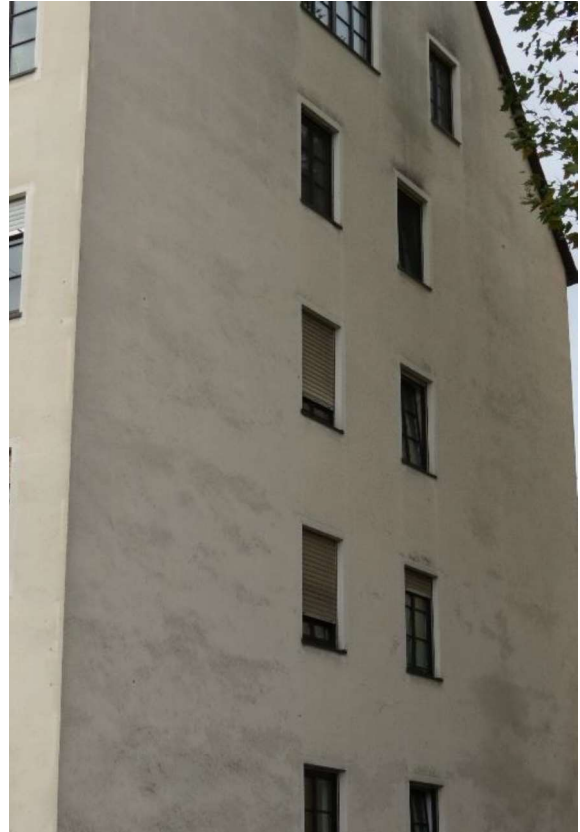
Object 96 was another building on which no renovation had been carried out since 2014. In Figure 7, the east side in 2014 is shown on the left and that in 2022 on the right. Since the last coat of paint was applied in 1995, some algae growth had occurred, which had only slightly increased in the past eight years. The façade is strongly shaded by a large tree and by the neighboring house, which is located a relatively short distance away. In addition, the light discolorations on the corners of the building (Figure 8) are still clearly visible in 2014 (left) and 2022 (right). The panel joints of the corner connection appear slightly here, but there has not been any noticeable change in the condition since the last assessment here either. Otherwise, there are no externally visible defects on the building facades.

Figure 7:  
East side of object 96 (left in 2014 and right in 2022) with algae formation and slight rippling at the insulation panel joints. (The rippling is not caused by cavities in the plaster but by unevenness in the plaster layer that is recognizable by the different graying.).

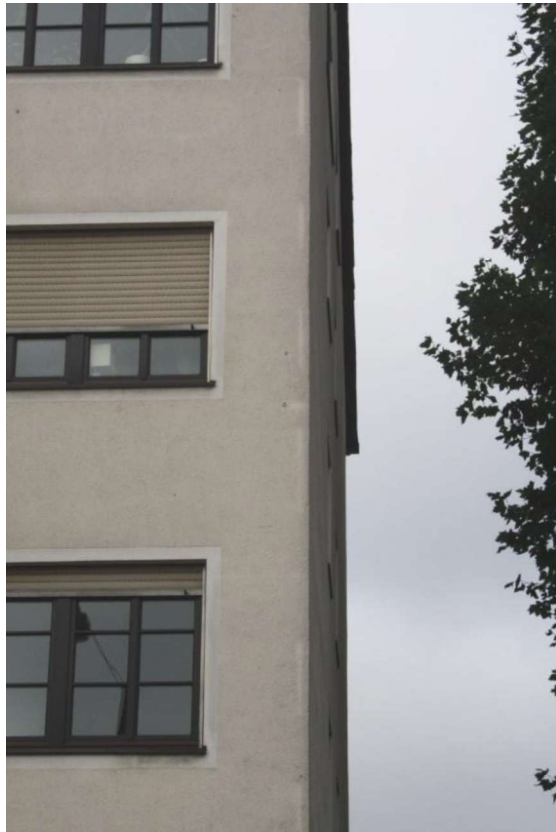
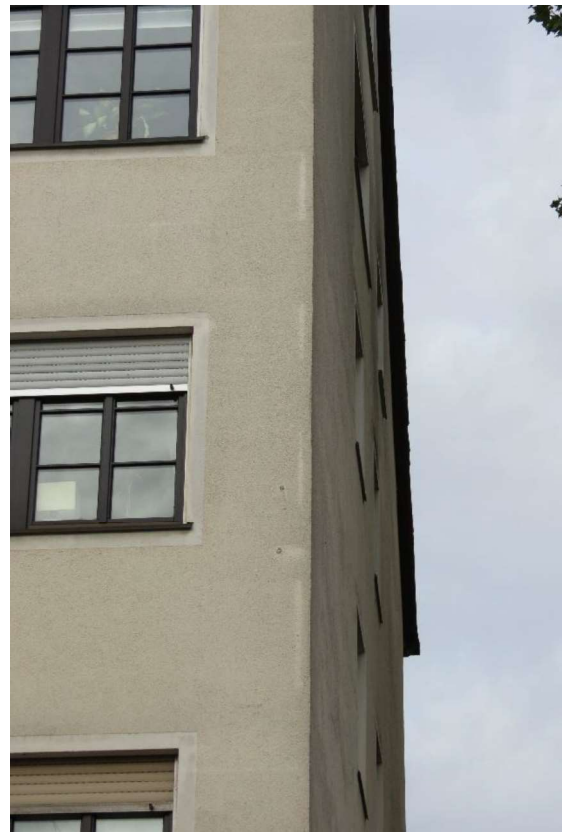
Figure 8:  
South-east corner of object 96 with appearance of the insulation panel joints  
through color differences (hardly visible from a distance).  
Left: View in 2014.  
Right: View in 2022.

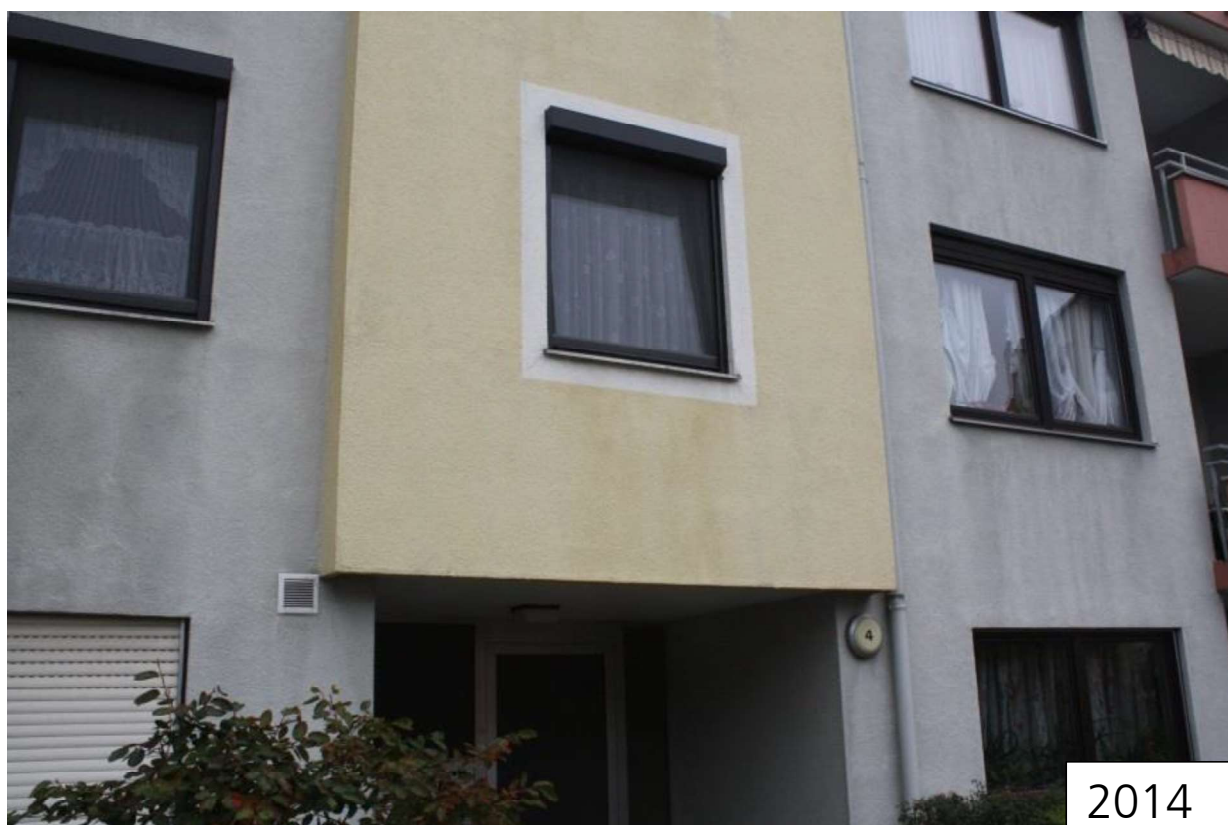
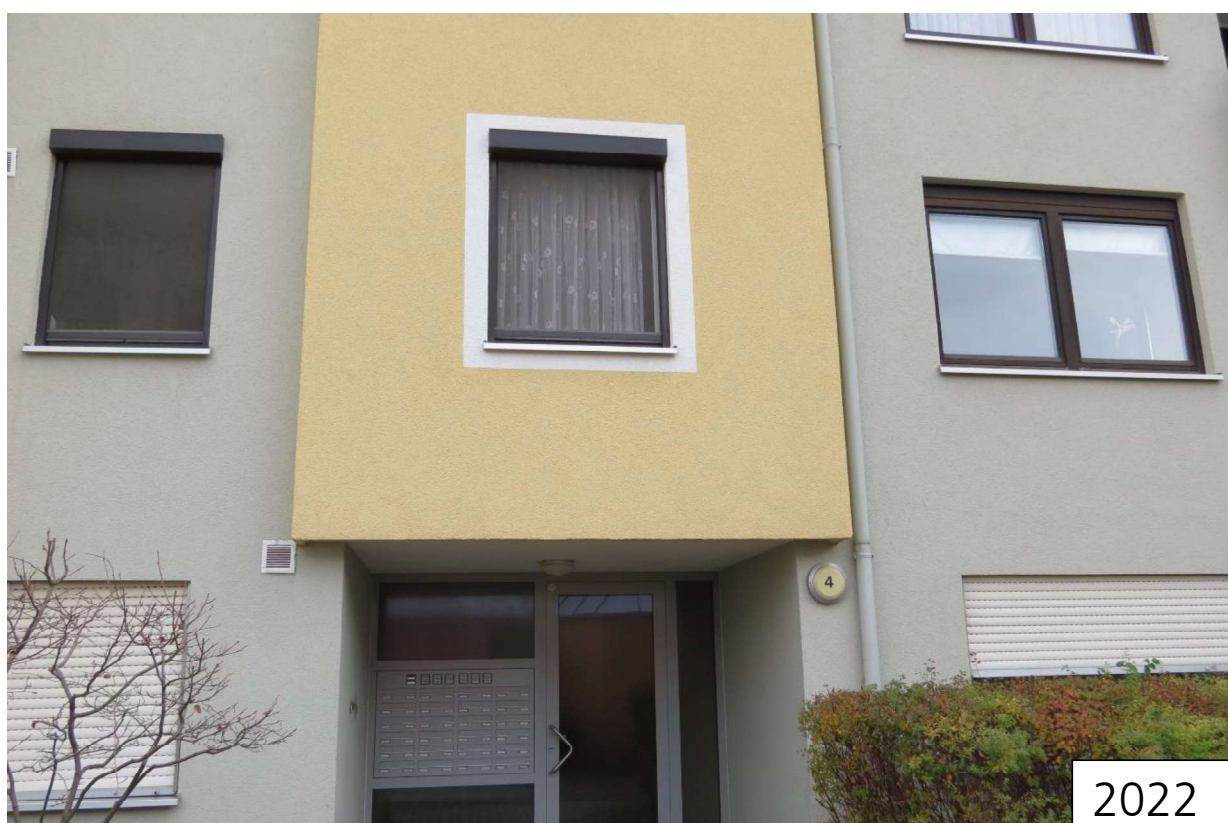
Figure 10:  
View of the exterior façade with west orientation in 2014 (top) and 2022 (bottom).

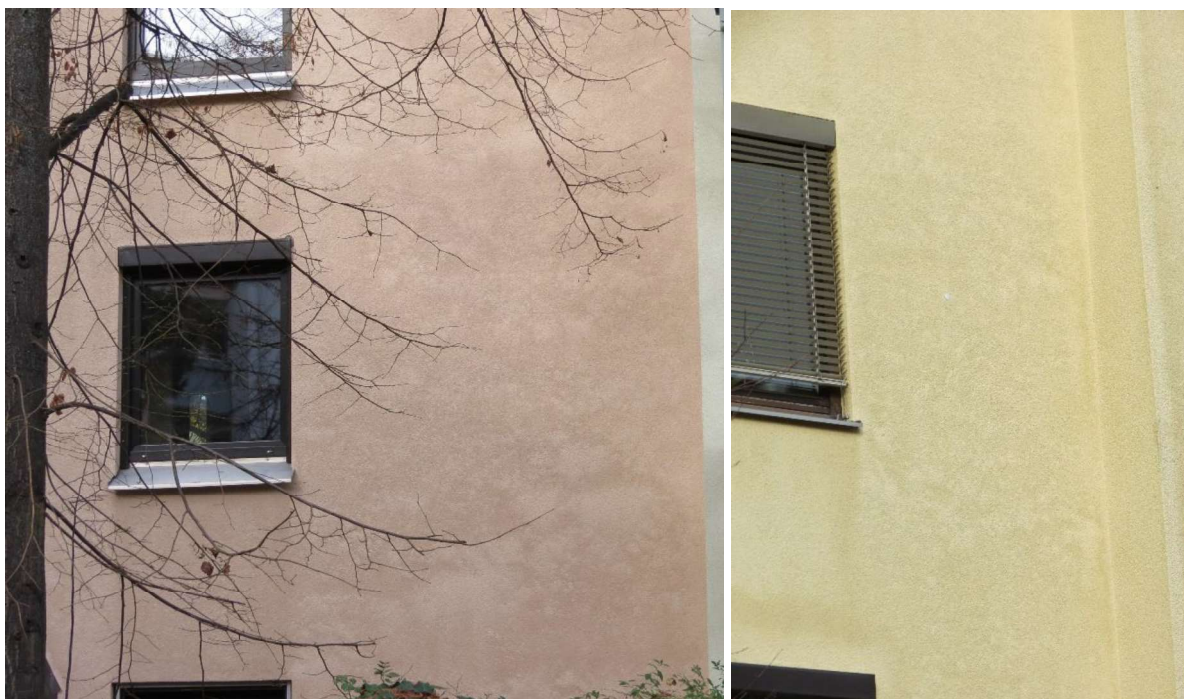
Figure 11:  
View of the east façade (left) and south-east façade (right) on object 95 with noticeable splotch formation but no crack formation.

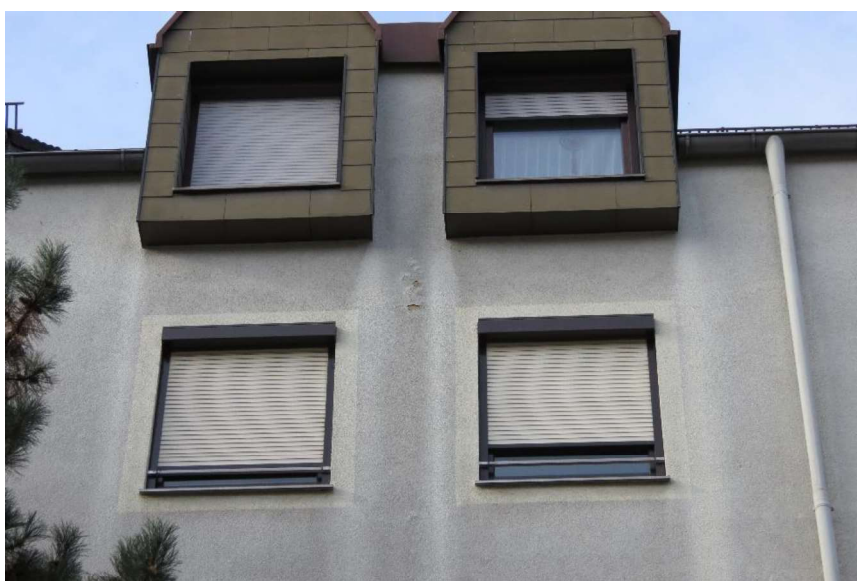
Figure 12:  
View of the east façade of the part of the residential complex that borders Mathildenstrasse. Noticeable crack formation and plaster separation between the windows.

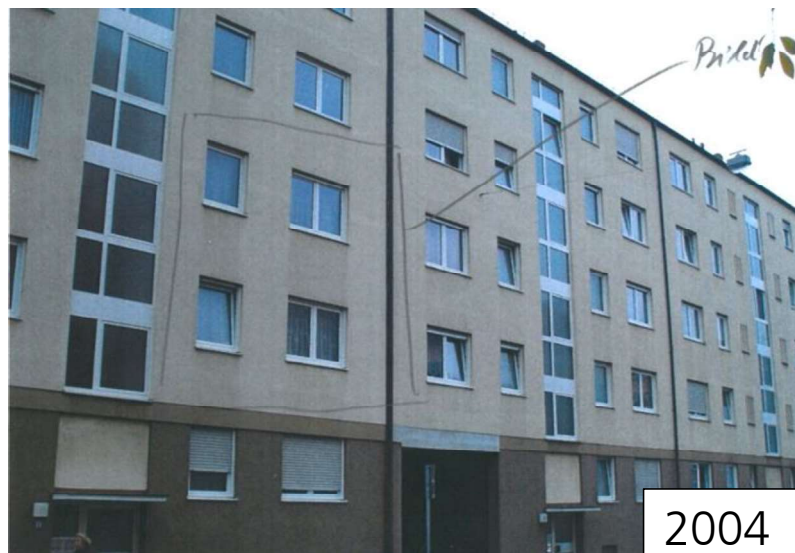
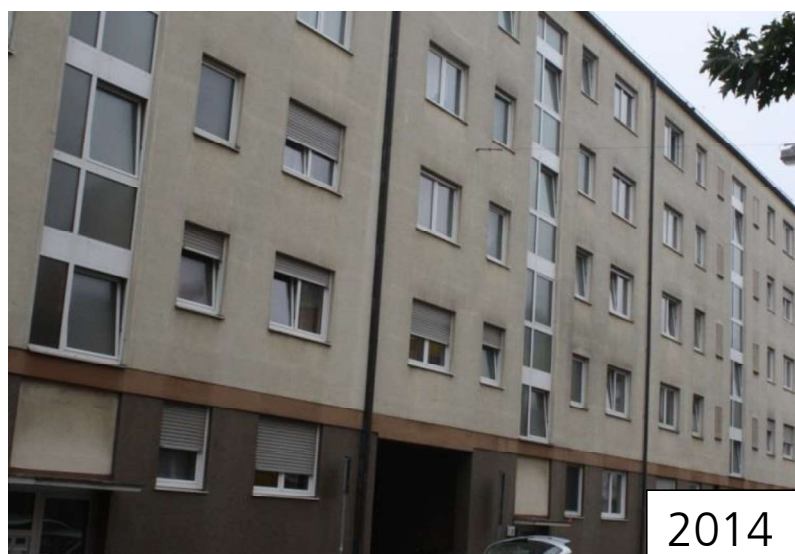
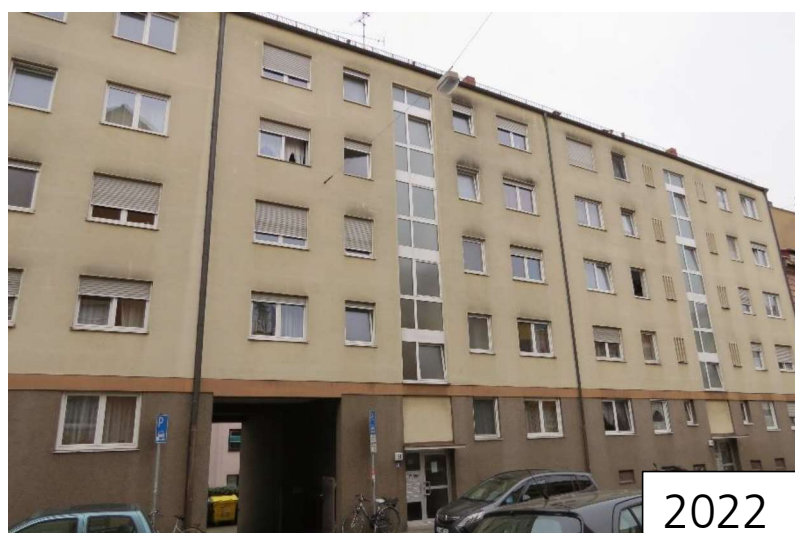
The changes in the north façade of object 51 can be seen in Figure 13 for the periods of 2004, 2014 and 2022. It was painted the last time 19 years ago. By now, the façade shows noticeable weathering characteristics as well as noticeable, extensive graying. Some lighter areas are still visible on the surface. It can be assumed that there is a joint of the insulation panel underneath. As a result of the different temperature conditions in these areas, a minimally changed microclimate occurs on the surface. Within the last eight years, the condition of the façade has optically grayed further, but no visible damage such as cracks or spalling is visible. Figure 14 additionally shows a section of the north façade in 2014 and 2022 on the upper stories. Clear condensation trails and light areas are visible on the plaster that appear along panel joints of the ETICS. No damage is visible. The south side of the building looks somewhat different, however. Isolated blistering was already visible here in 2014, and this has now developed further into noticeable cracks and bulges in the plaster. Figure 15 shows a close-up of the south façade in a balcony and at the connection to the garage in which blistering, and cracks are visible when comparing 2014 and 2022.

Figure 13:  
North façade of object 51 in 2004 (top), 2014 (center) and 2022 (bottom).

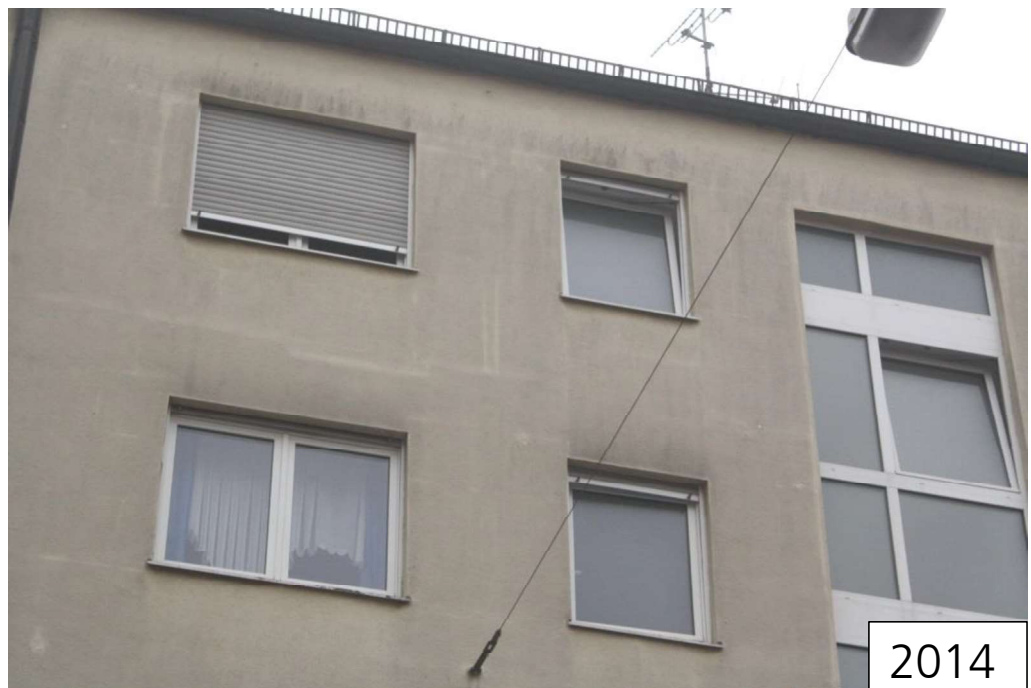
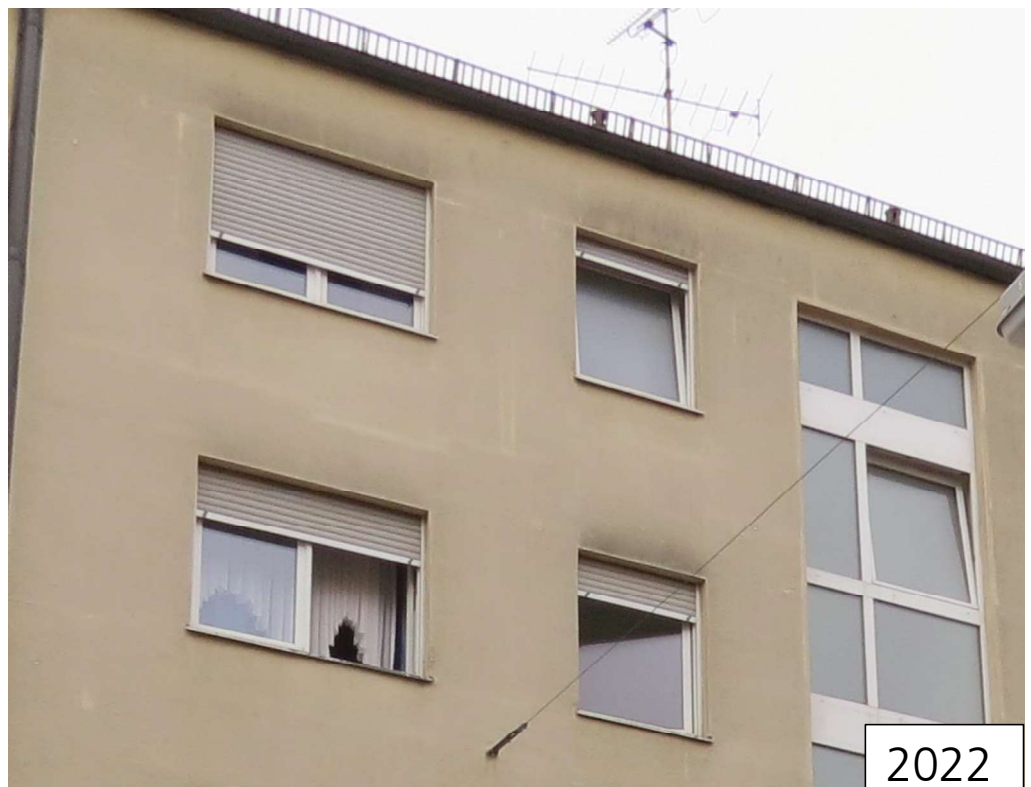
Figure 14:  
View of the top north facade in 2014 (top) and 2022 (bottom) of object 51 on which noticeable condensation trails and light areas along the panel joints of the ETIC system are clearly visible.

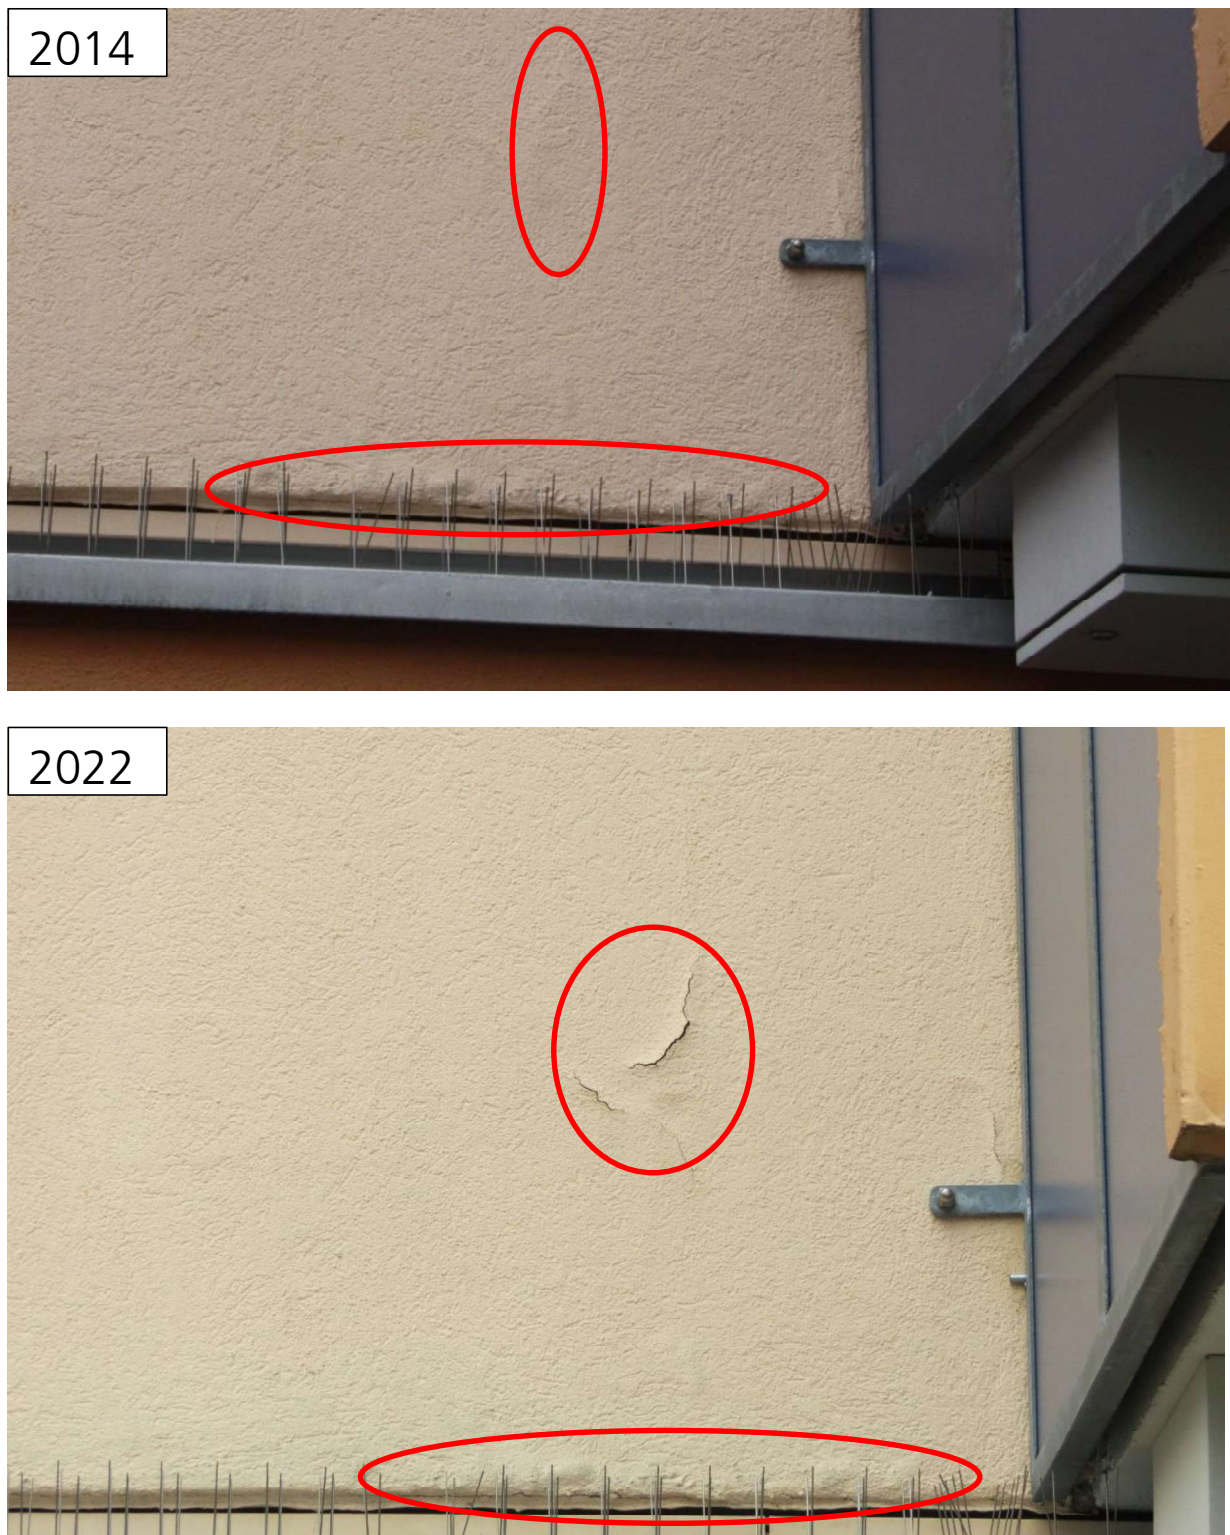
Figure 15:  
View of the façade connection to the garages in 2014 (top) and 2022 (bottom) on the south side of object 51; noticeable blistering or crack formation is visible here on the lower plaster edge as well as occasionally in the plaster surface.

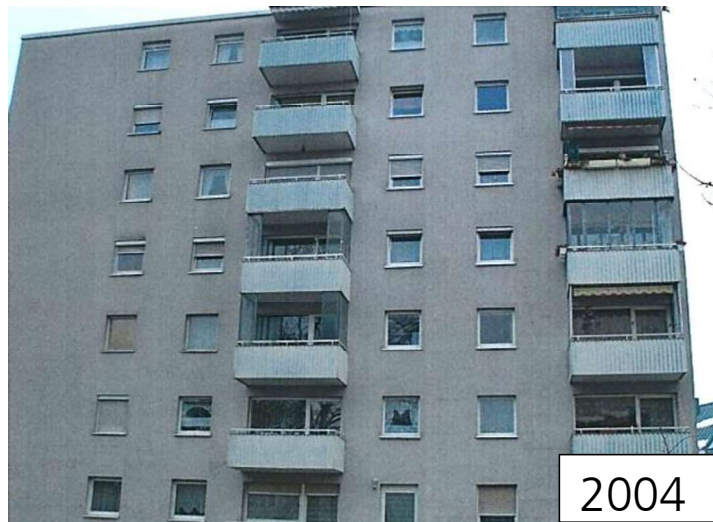
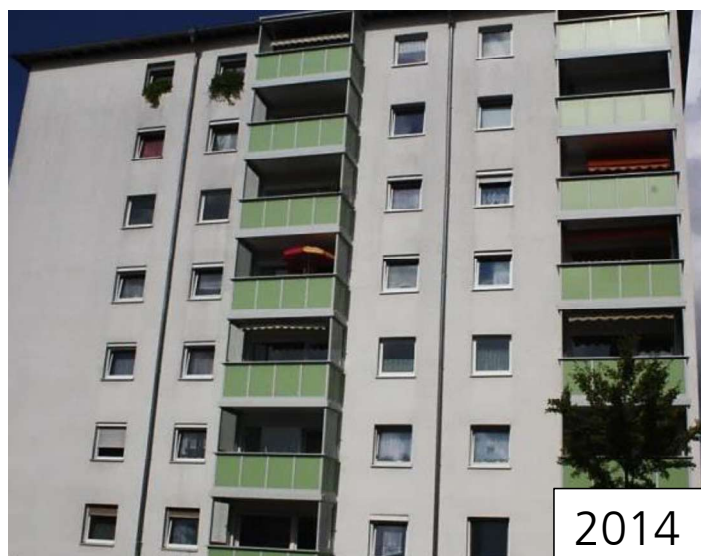
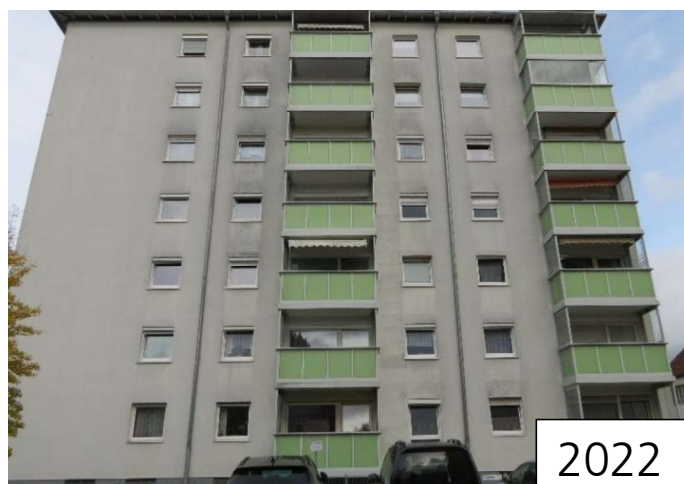
Object 56 in Neumarkt i. d. Oberpfalz was last painted in 2008. Figure 16 shows the view of the south façade in 2004 at the top, in 2014 in the center and in 2022 at the bottom. The façades have considerably grayed in the past eight years, but no crack formation or spalling is visible. On the east side, a slight rippling (see Figure 17 - top in 2014, bottom in 2022) in the plaster surface is visible where the edges of the ETICS panels appear with an oblique light incidence. This phenomenon is not considered a defect since it can occur due to slight differences in the thickness of the insulation panels and due to fluctuations in the layer thicknesses when a thin plaster is applied. Otherwise, a noticeable graying is visible over the entire surface here as well.

Figure 16:  
South view of the façade of object 56 (formerly Efastr.), in 2004 (top), 2014 (center) and 2022 (bottom).

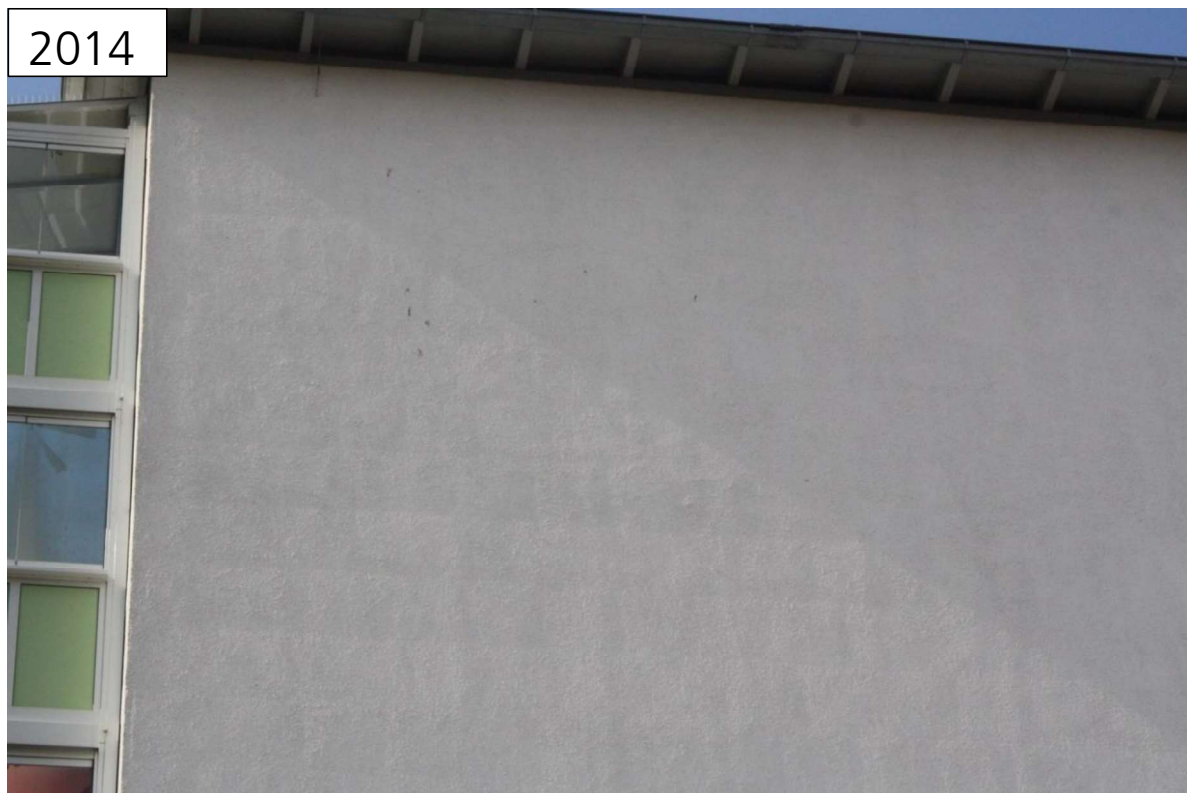
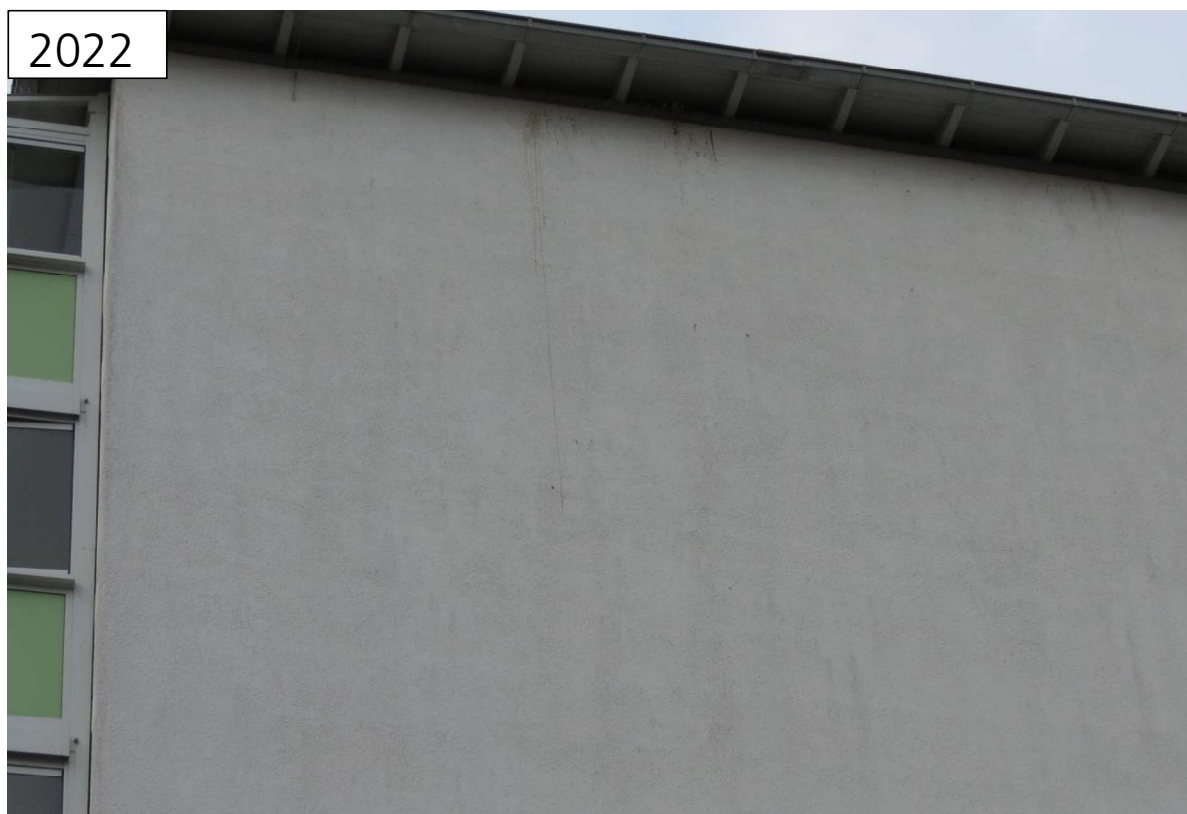
Figure 17:  
East façade in 2014 (top) and 2022 (bottom) of object 56 with slight rippling at the panel joints of the insulation, which is only visible with oblique light incidence.

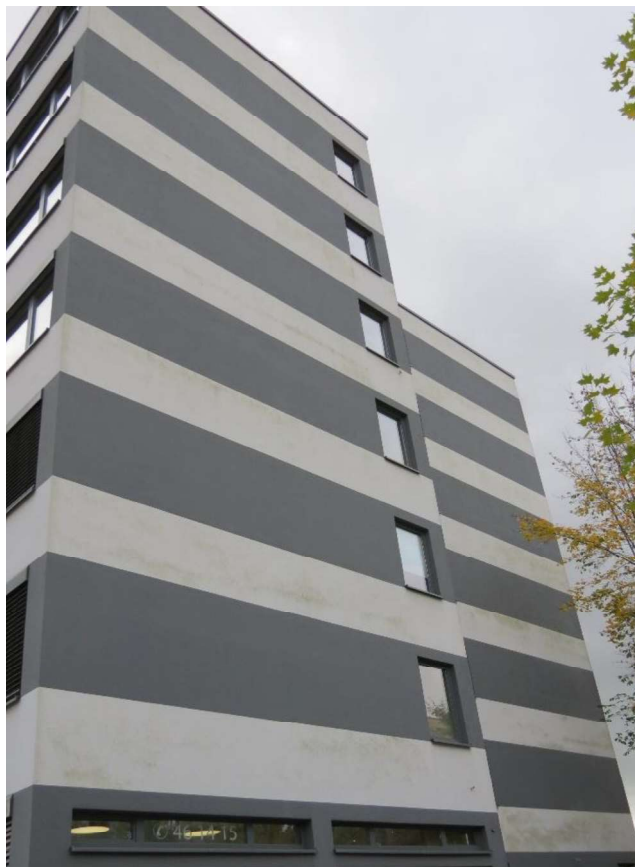
Figure 19:  
North façade of object 54 in Neumarkt in 2022 with noticeable greening in the white façade areas.

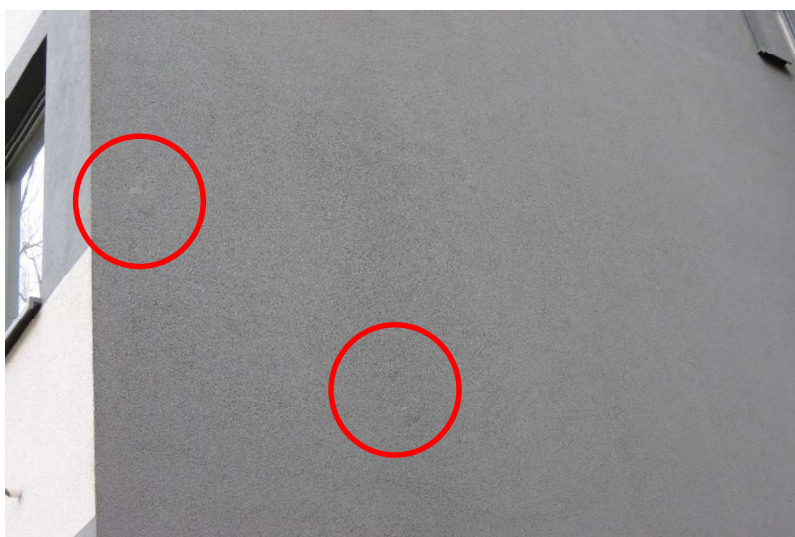
Figure 20:  
The west façade, which is offset to the rear, next to the back entrance of object 54 in Neumarkt in 2022 with noticeable blistering.

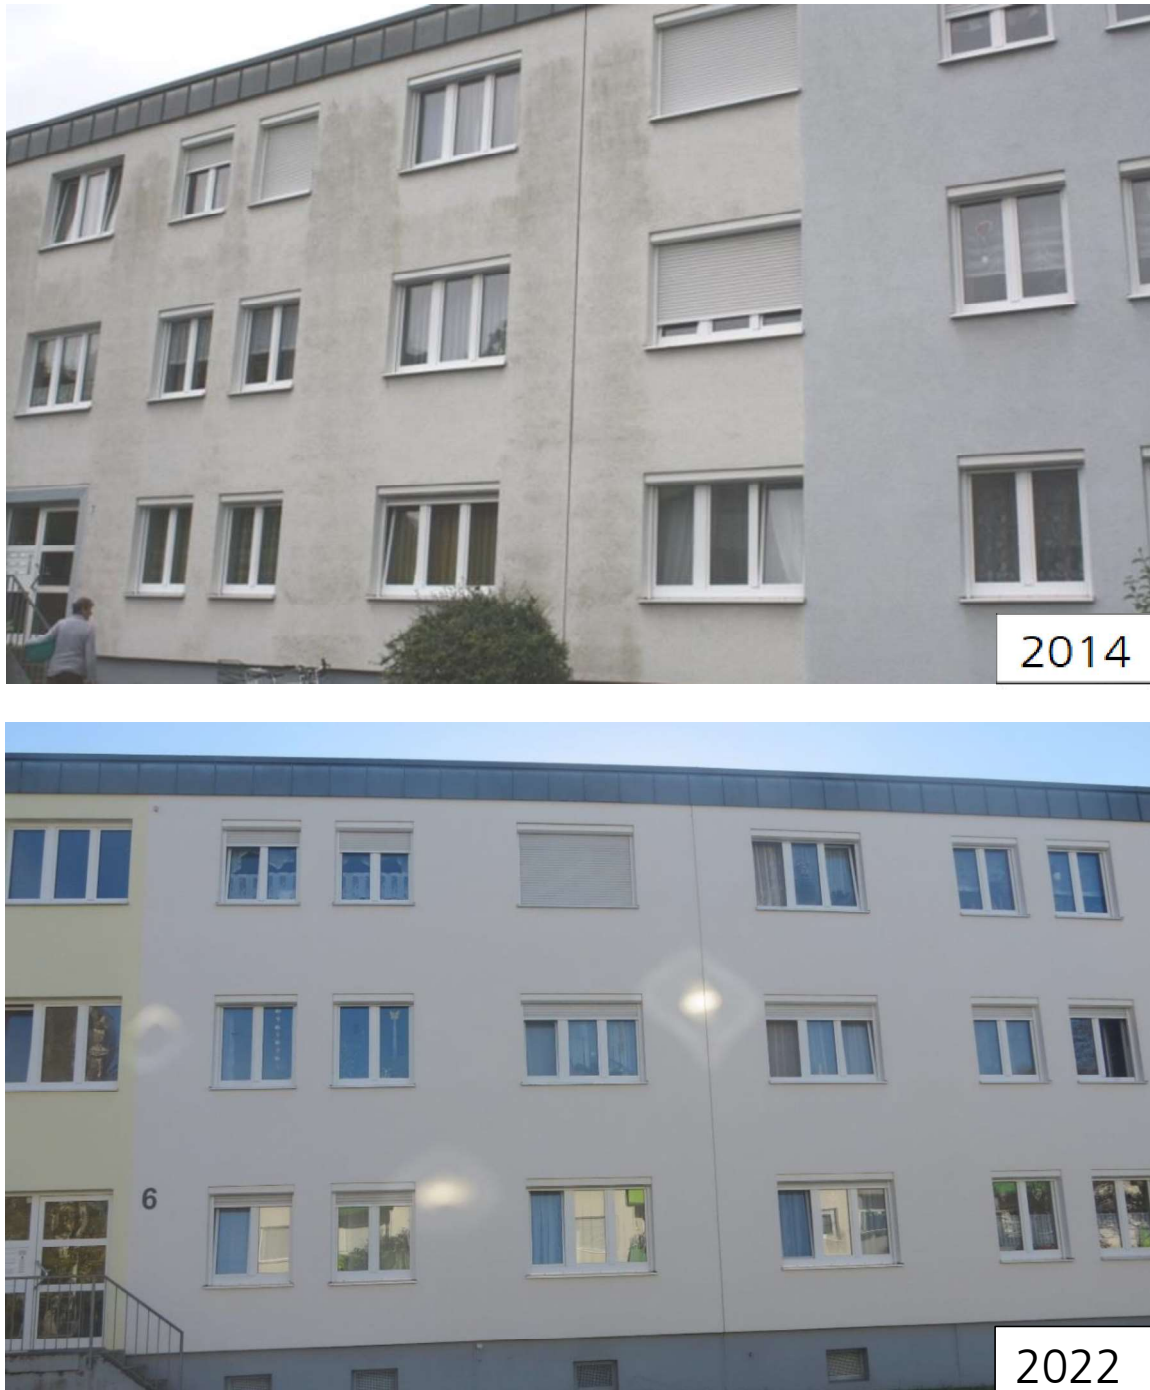
On object 34, the façade coating had been renovated with a silicone resin paint in 2020 and was without visible defects. The comparison of the façade view from 2014 to 2022 is shown in Figure 21.

Figure 21:  
North façade of object 34, in 2014 (top) with noticeable discolorations of the white plaster surfaces and in 2022 (bottom), freshly painted approx. two years before.

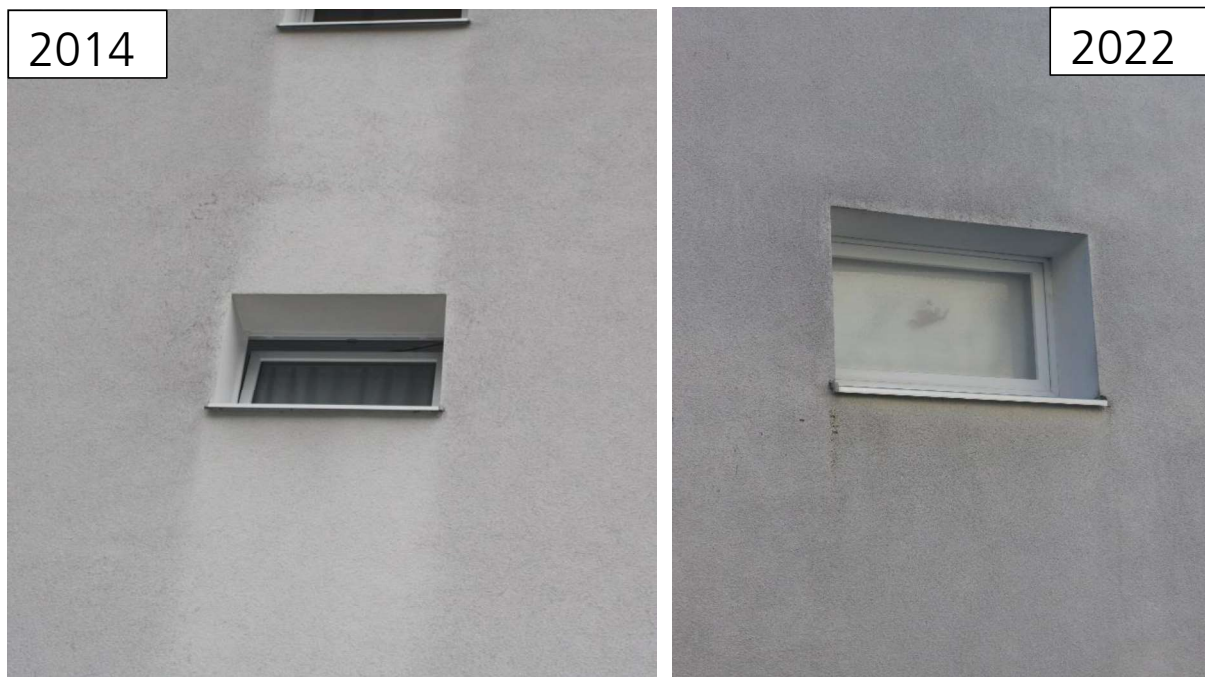
Figure 29:  
View of the west façade of object 31; in 2014, noticeable color differences could be seen between the area underneath the windows and the undisturbed façade; in 2022 an even graying is visible.

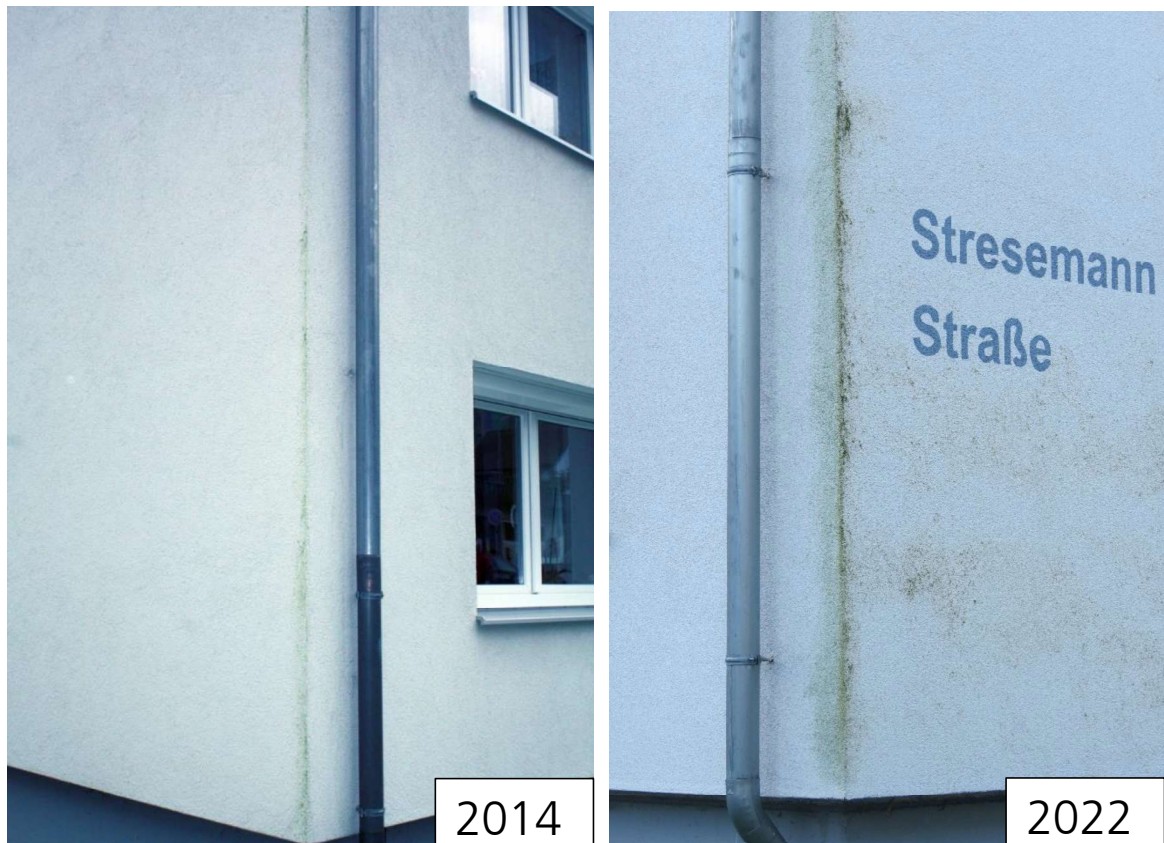
Figure 31:  
View of the south-west corner of the building in 2014 (left) of object 30 and the north-west corner of the building in 2022 (right) with algae growth on the edge of the building.

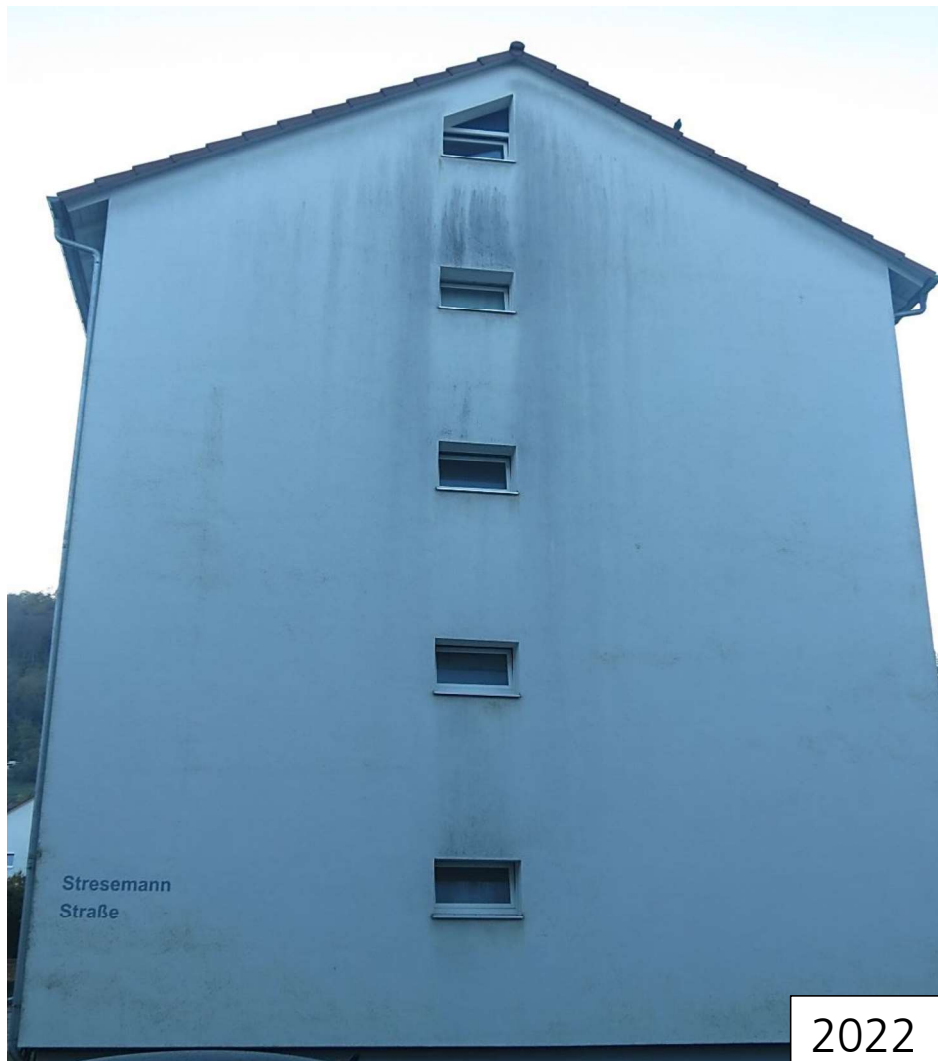
On object 30, no façade renovation measures had been carried out since 2006 either. Figure 30 shows the view of the north façade in 2004, 2014 and 2022. On the façade, the growth of black fungus is seen above the windows on several residential units on the first floor, just like in 2004 and 2014; this is due to windows that had been tilted open for a longer time. Here, moist, warm indoor air flows upwards along the façade and condensate forms because of the cold surface, leading to the formation and growth of black fungus. Except for the usual graying, no defects could be detected on the façade. Another, more noticeable detail can be seen in Figure 31. In 2014, algae growth occurred on the south-west corner of the building, which only appeared on the edge of the building. During the assessment in 2022, there was algae growth on the north-west corner of the building as well as the beginning of algae growth over the surface of the façade. In addition, significant condensation trails were visible in the upper area of the west façade (see Figure 32).

Figure 32:  
View of the west façade (2022) of object 30 with noticeable condensation trails and the beginnings of algae growth.
