IBP report HTB-005EN/2023

## Assessment of the long-term reliability of installed external thermal insulation composite systems

Conducted on behalf of  
Verband für Dämmsysteme, Putz und Mörtel e.V.  
Reinhardtstraße 14  
10117 Berlin, Germany

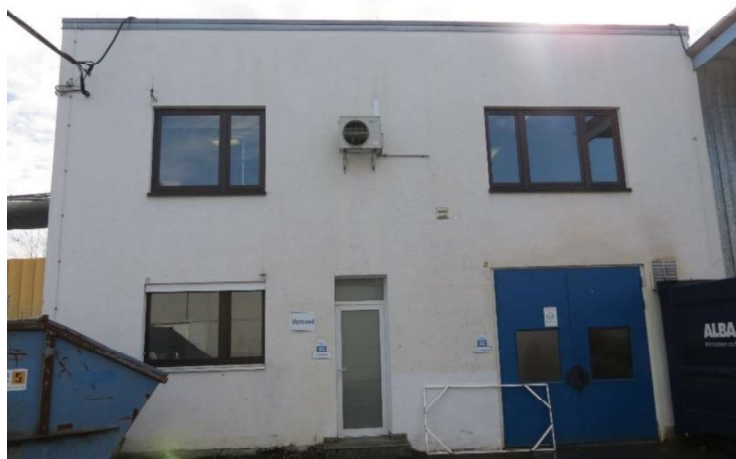
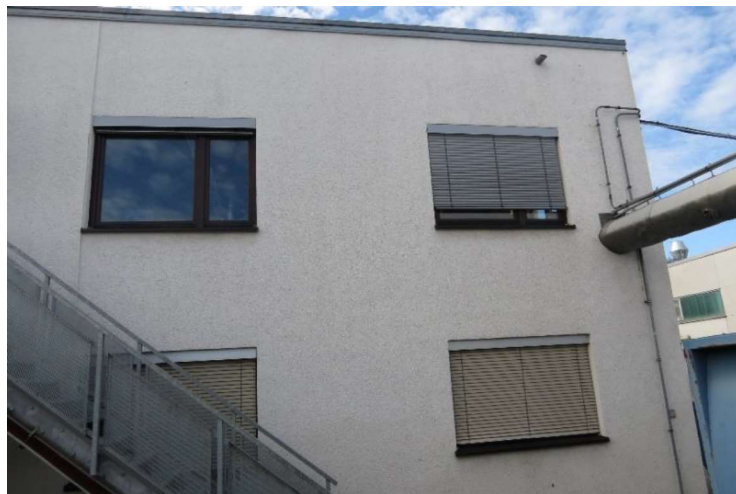
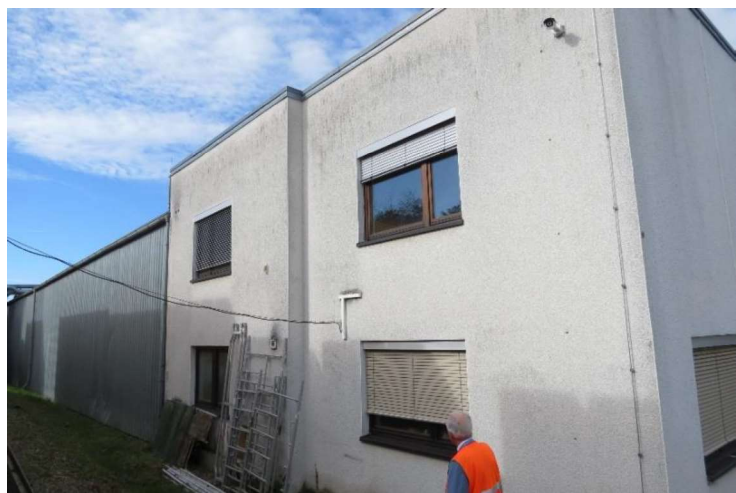
Object 2 is a workshop building that was built in 1973 and insulated in 1986 with 5 cm PUR/PIR insulation and mineral plaster. Since then, the façades have not been renovated anymore. The façade construction was thus 36 years old. No damage is visible over any of the surfaces (see Figure 33). Some damage can be seen only in the base area, although this is likely to have been caused by mechanical influences. Biological growth is also discernible in the lower area of the façade, which is probably due to spray water from the ground. On the south side (Figure 34), noticeable gray areas and condensation trails are visible in the upper façade area.

Figure 33:  
View of the three façades of object 2.  
Top: north façade.  
Center: east façade.  
Bottom: south façade.

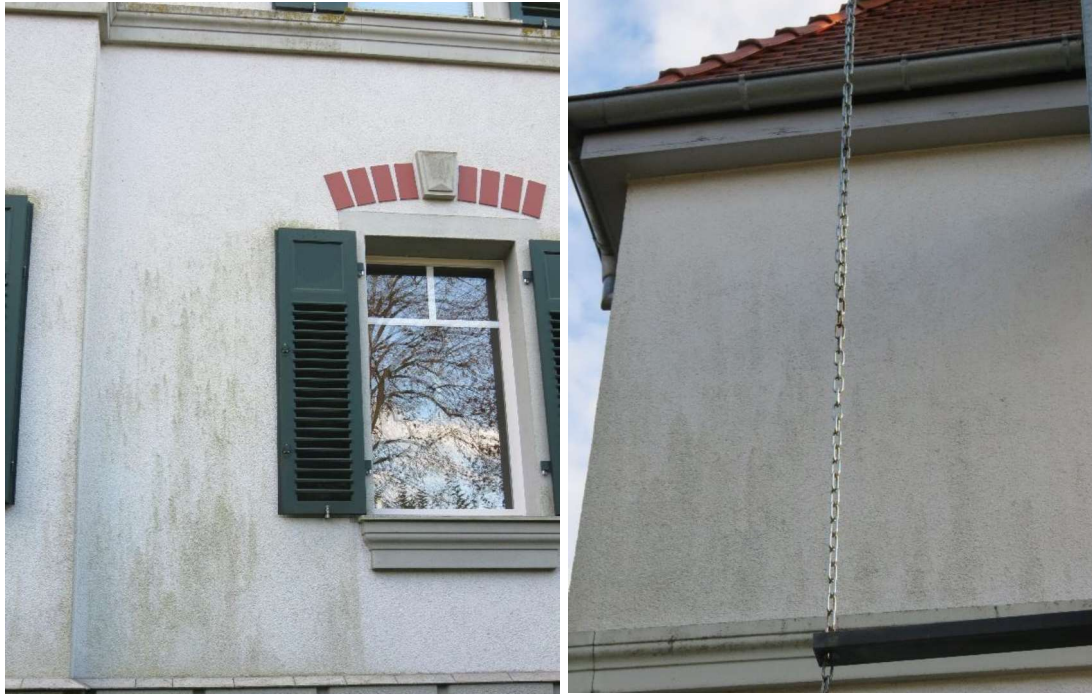
Figure 43:  
Close-up of the NW façade (left) and SW façade (right) with noticeable green-  
ing.

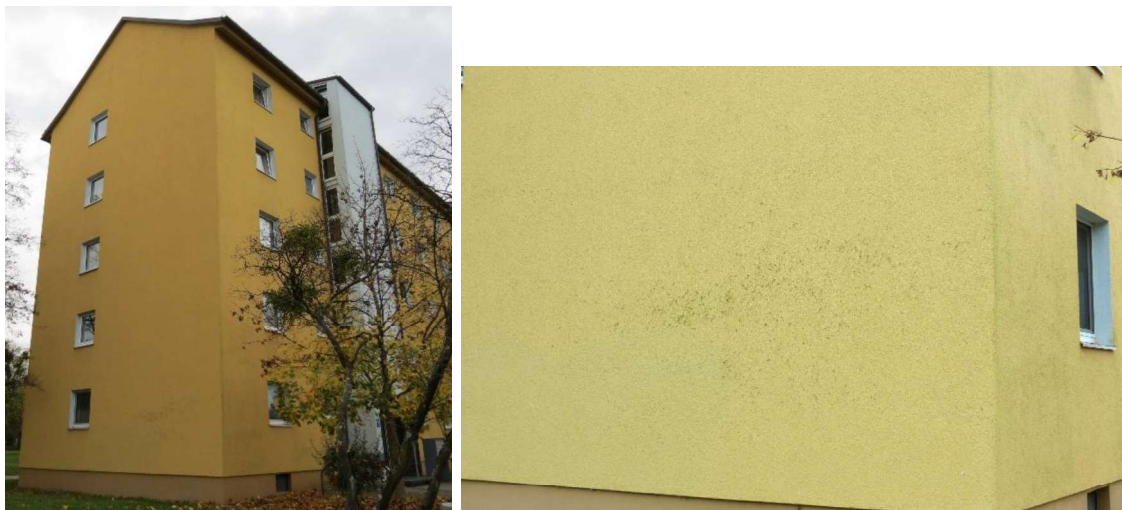
Figure 48:  
View of the east façade of house number 85, including a close-up of the lower north-east façade surface with algae growth.

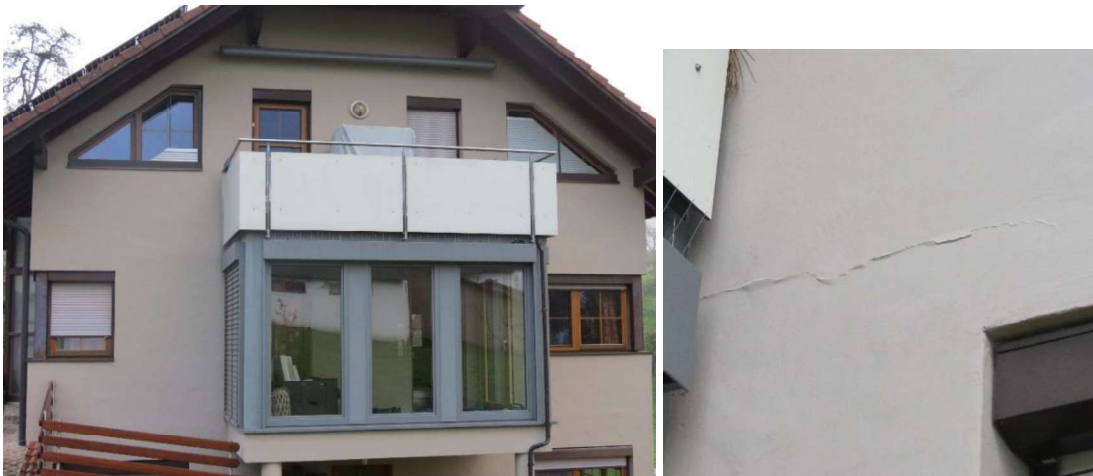
Figure 54:  
South view of the façade (left) of object 10. Crack formation visible at the upper connection of the conservatory (right).

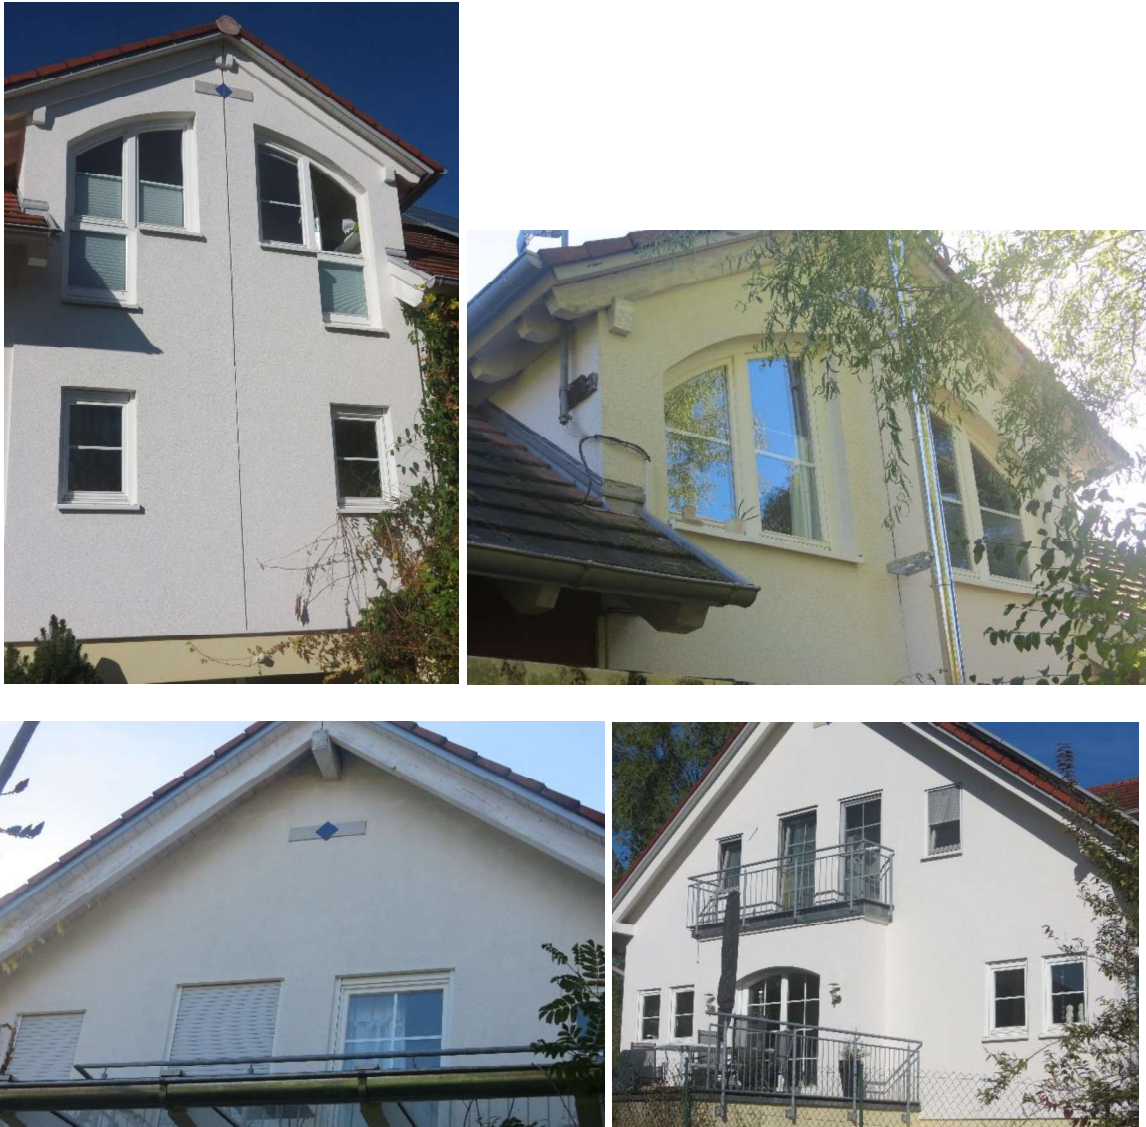
(in original condition). On the east half, a slight green coating was visible, while the west half was bright white. No crack formation, blistering or spalling is visible on any façade.

Figure 57:  
Views of the façades of object 13.  
Top left: south-east façade - painted in 2020.  
Top right: north-west façade - only western half painted in 2020.  
Bottom left: north - east façade.  
Bottom right: south-west façade - painted in 2020.
