IBP report HTB-005EN/2023

## Assessment of the long-term reliability of installed external thermal insulation composite systems

Conducted on behalf of  
Verband für Dämmsysteme, Putz und Mörtel e.V.  
Reinhardtstraße 14  
10117 Berlin, Germany

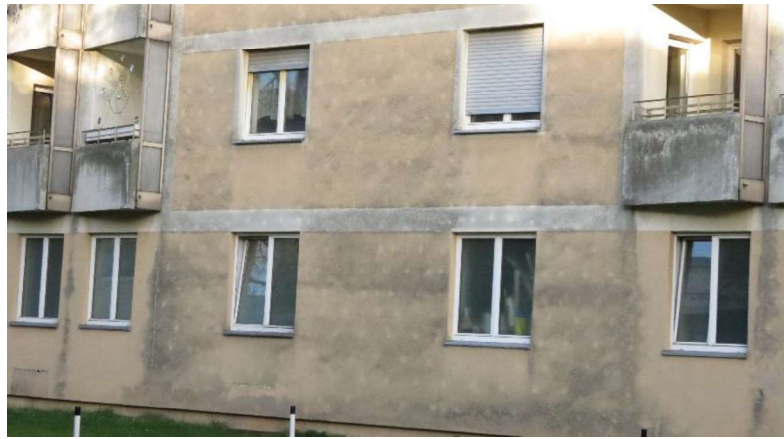
Figure 4 and Figure 5 show the west façade of object 16 (retirement home in Munich). The change in the façade over 33 years can be clearly seen here. The top image shows the façade three years after a 60 mm thick mineral wool insulation was applied (1989). The façade had not been reworked since it was created. In the lower image of Figure 4, some graying and algae formation can already be seen on unprotected wall sections (2004). The upper image of Figure 5 shows the façade condition in 2014, and the lower image shows the condition of the façade today after 33 years. In the meantime, nearly the entire façade has grayed, or the façade color has weathered away. The fastening dowels of the ETIC system are clearly visible (see Figure 6). The high weathering stress on the façade is also indicated by the condition of the balustrades, which show a considerably stronger discoloration than the ETIC system. No significant defects are visible on any of the four façade orientations. No cracks are visible over the surface. This is the oldest assessed building not maintained with functional ETICS, even though it needs renovation from an optical point of view. Overall, the façade has not significantly deteriorated since the last assessment.

Figure 6:  
View of the facade of object 16. With noticeable appearance of the dowels on the first and second floor.

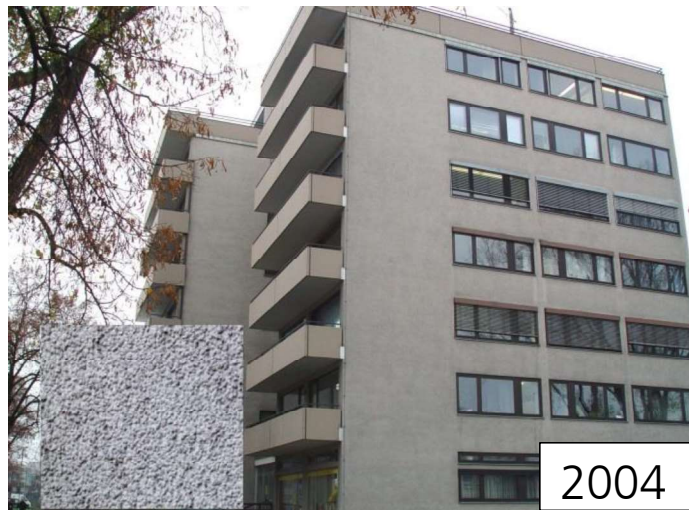
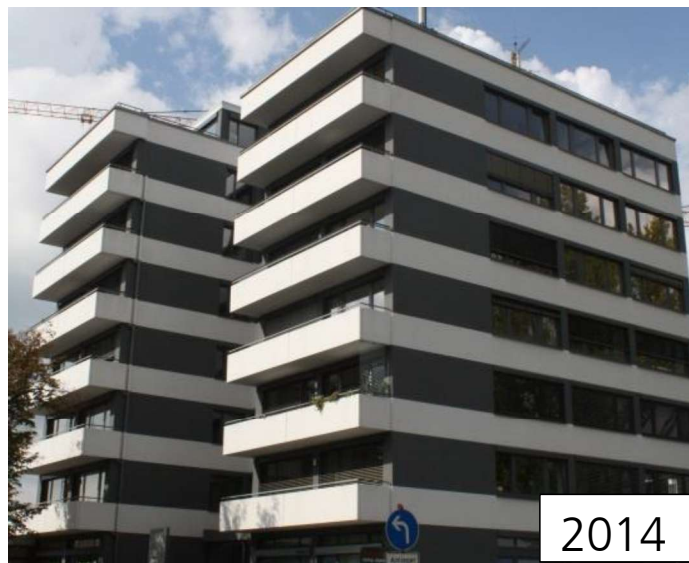
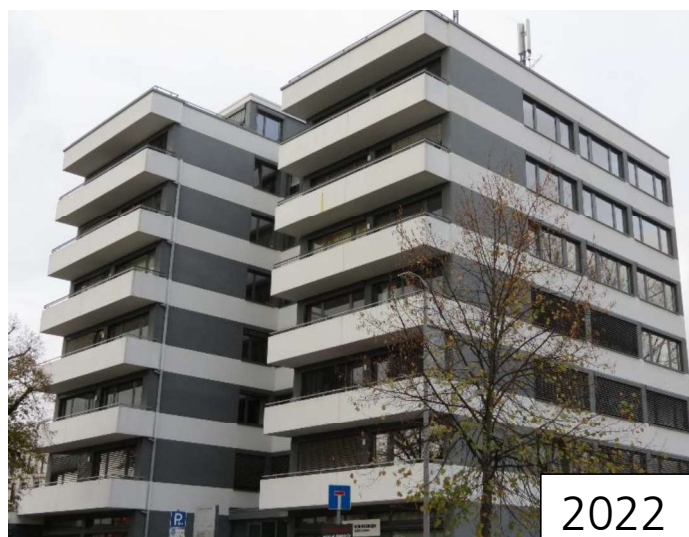
A further building that had not been renovated in the past eight years was object 54 in Neumarkt i. d. Oberpfalz. Figure 18 shows images of the east and south façade in 2004, 2014 and 2022. No significant changes are visible on the south and east façade from a distance. Upon closer inspection, a slight green growth is apparent in the white color strips in some places on the east side as well as a slight blistering in one place. The north side (see Figure 19) of the building shows a strong greening. Here the gray stripes are also green. The thick vegetation on the north side of the building strongly favors the growth of algae on the shaded side. In addition, blisters in the plaster are also visible on the west façade, which is offset to the rear, next to the back entrance (see Figure 20).

Figure 18:  
East and south façade (from right) of object 54 in Neumarkt in 2004 (top),  
2014 (center) and 2022 (bottom).

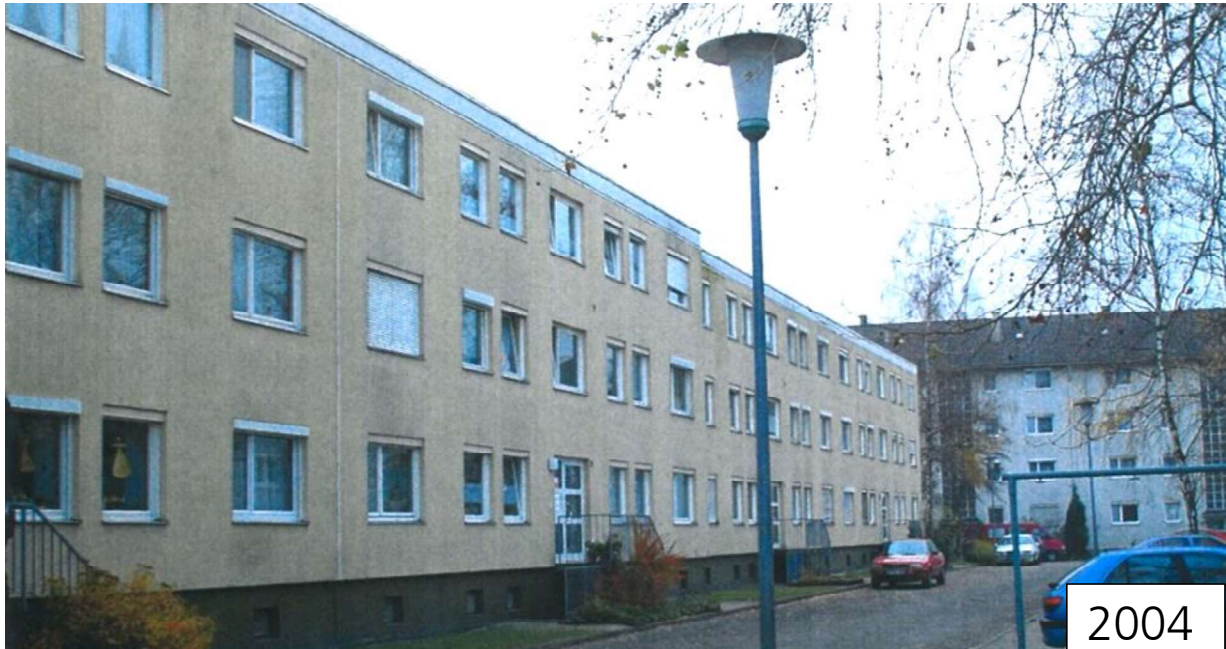
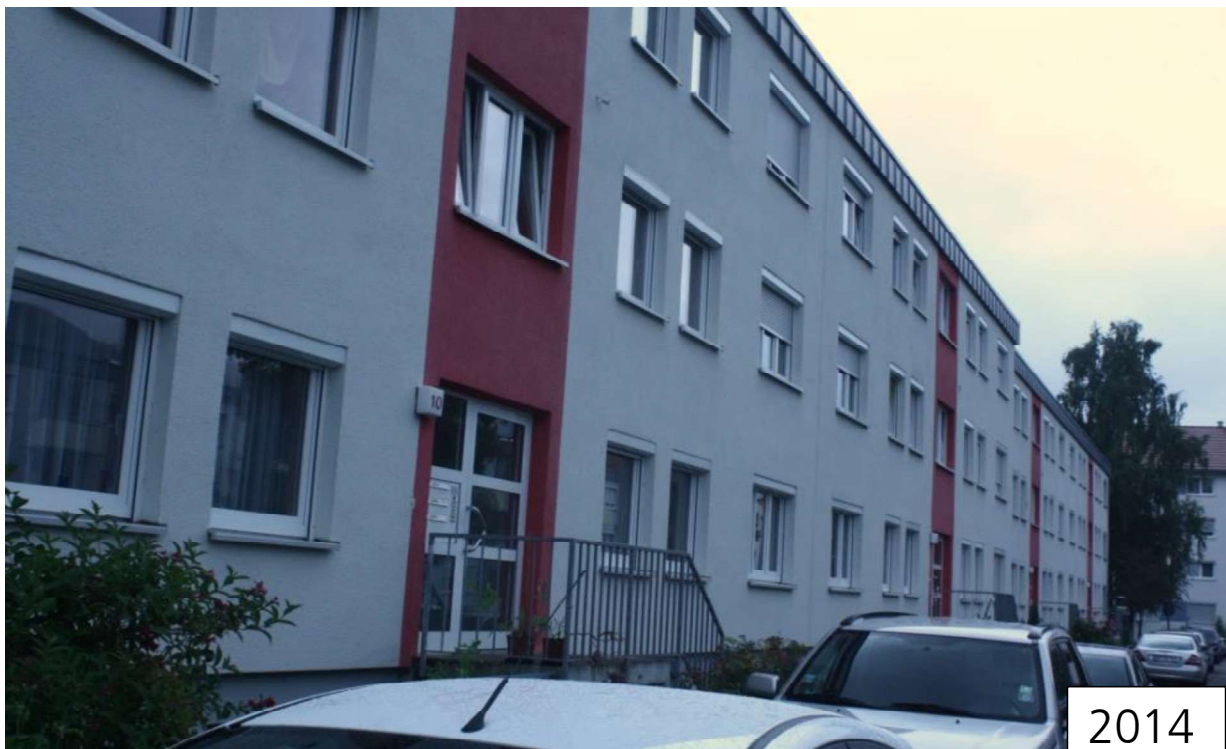
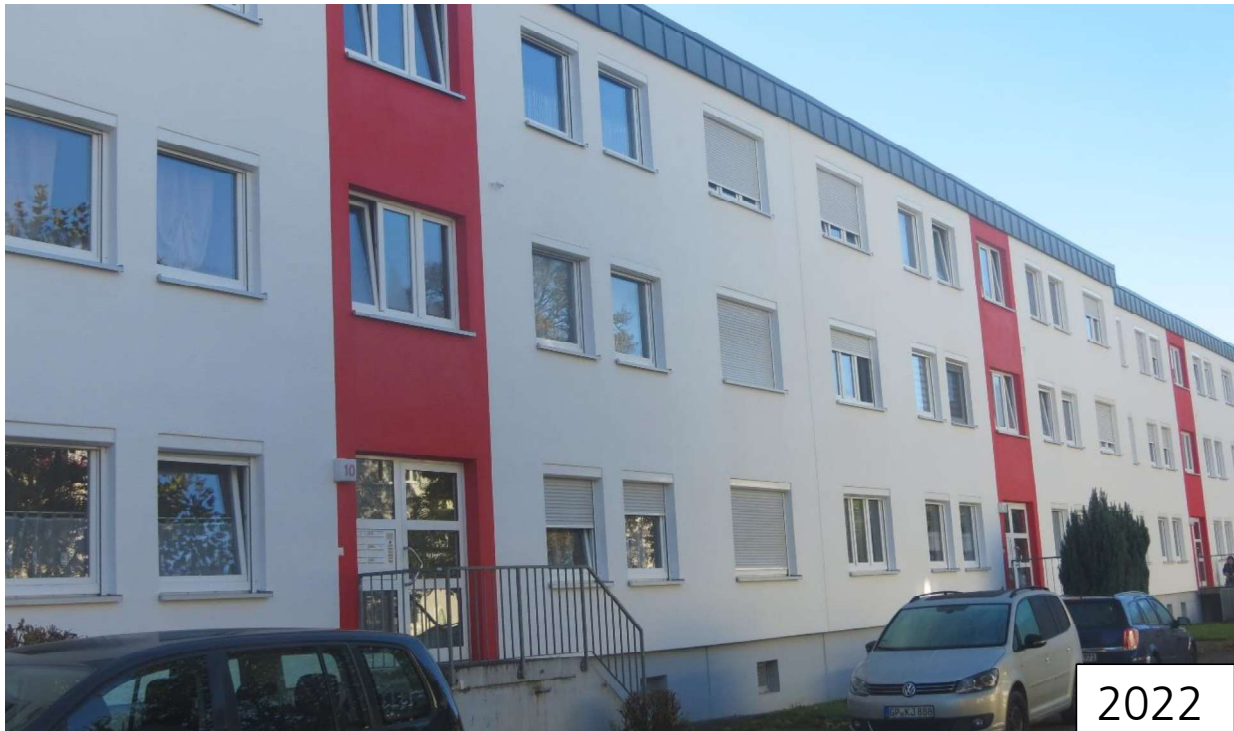
Object 33 is characterized by the same structure and the same location as the previous property 34, with the difference that this building façade was renovated in 2022 with a new coat of paint. Figure 22 shows images of the north façade in 2004, 2014 and 2022. No defects are visible.

Figure 22:  
North view of object 33 (Bolzstr. 9–12, Geislingen a. d. Steige), in 2004 (top), 2014 (center) and 2022 (below).

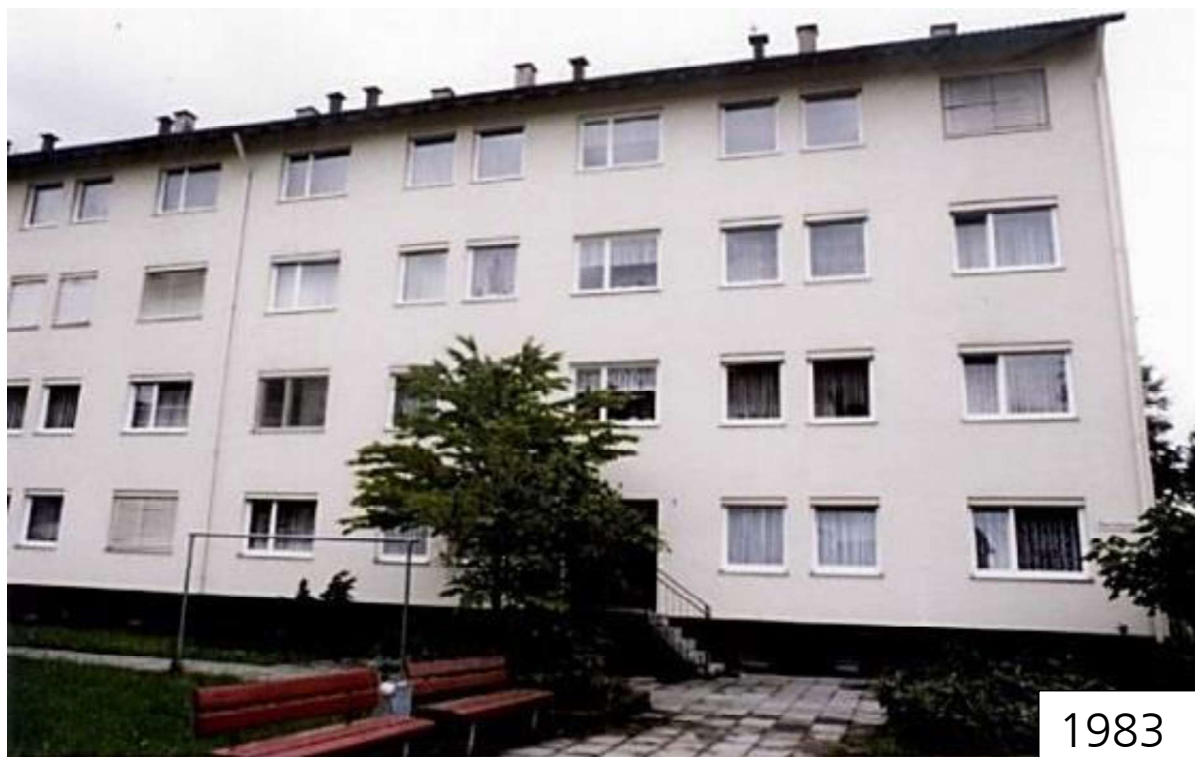
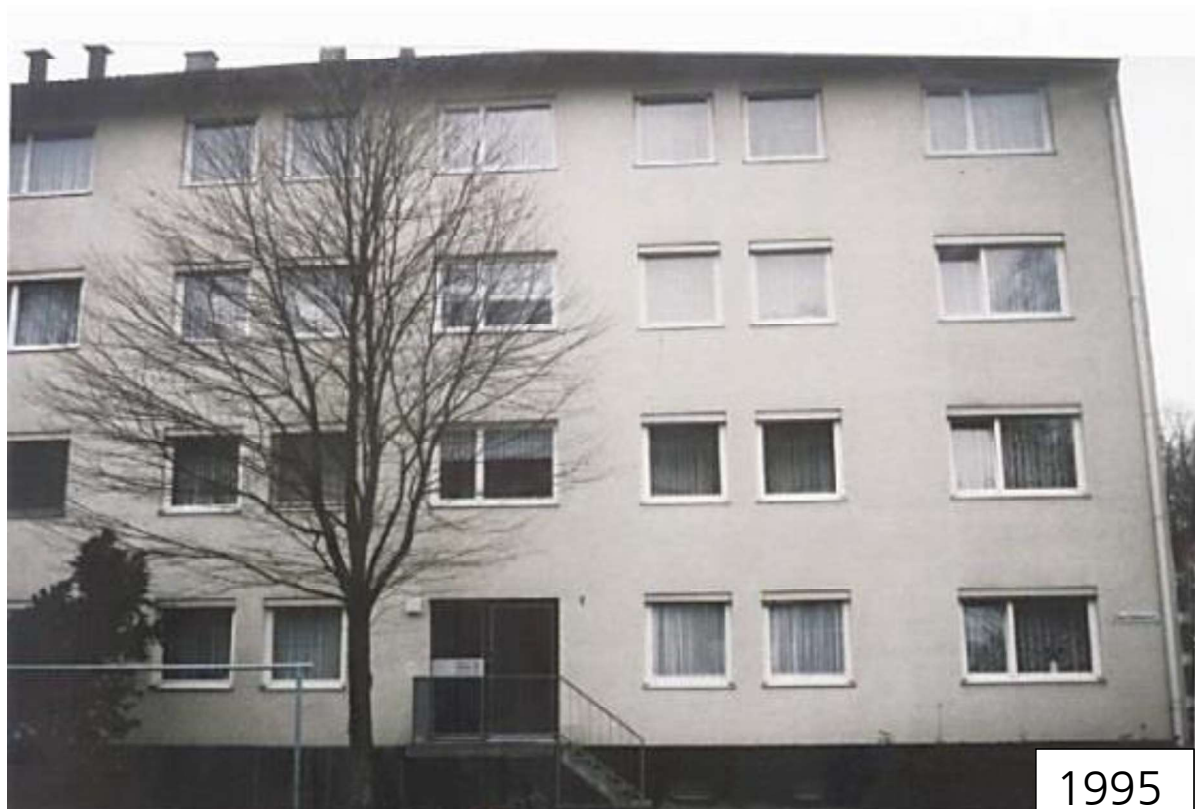
For object 32, Figure 23 to Figure 25 show the chronological sequence of the views of the north façade over the course of the last 39 years. In the period of 1981–2006, no work took place on the façade. Since the energy-related renovation measures in 2006, the façade of the building had not been worked on. The pictures from 1983 to 2022 do not show any crack formation or spalling defects over the years. The picture from 2022, however, shows noticeable discolorations and appearance of the ETICS dowels in the upper stories on the façade. Figure 26 shows the east view of the building in comparison: in 2014 on the left and in 2022 on the right. The graying has become more noticeable, and the ETICS dowels clearly appear on the entire façade surface. In the connection area to the grass strip, it is evident that algae growth / soiling has considerably increased since 2014 (see Figure 27). This is due to the short distance to the grassy area and the related spray water.

Figure 23:  
View of the north façade of property 32 (Ebertstr. 1–7, Geislingen a. d. Steige)  
in the period between 1983 and 1995.

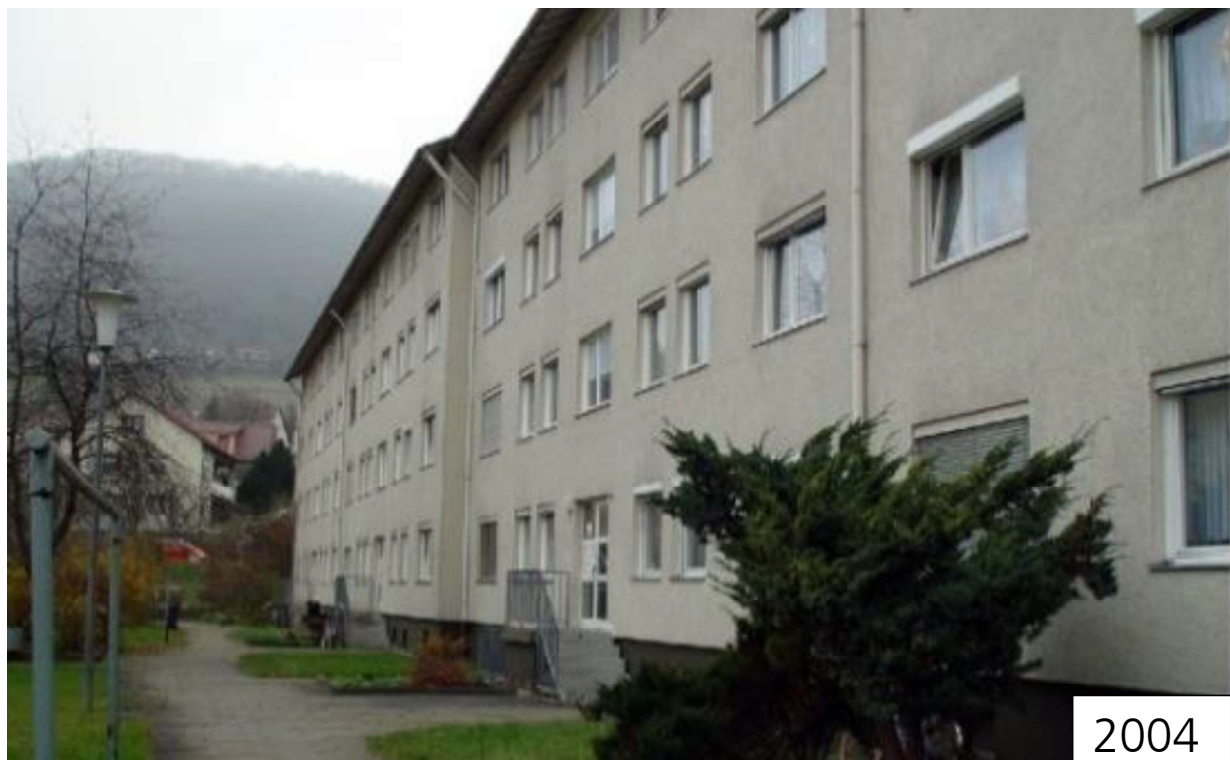
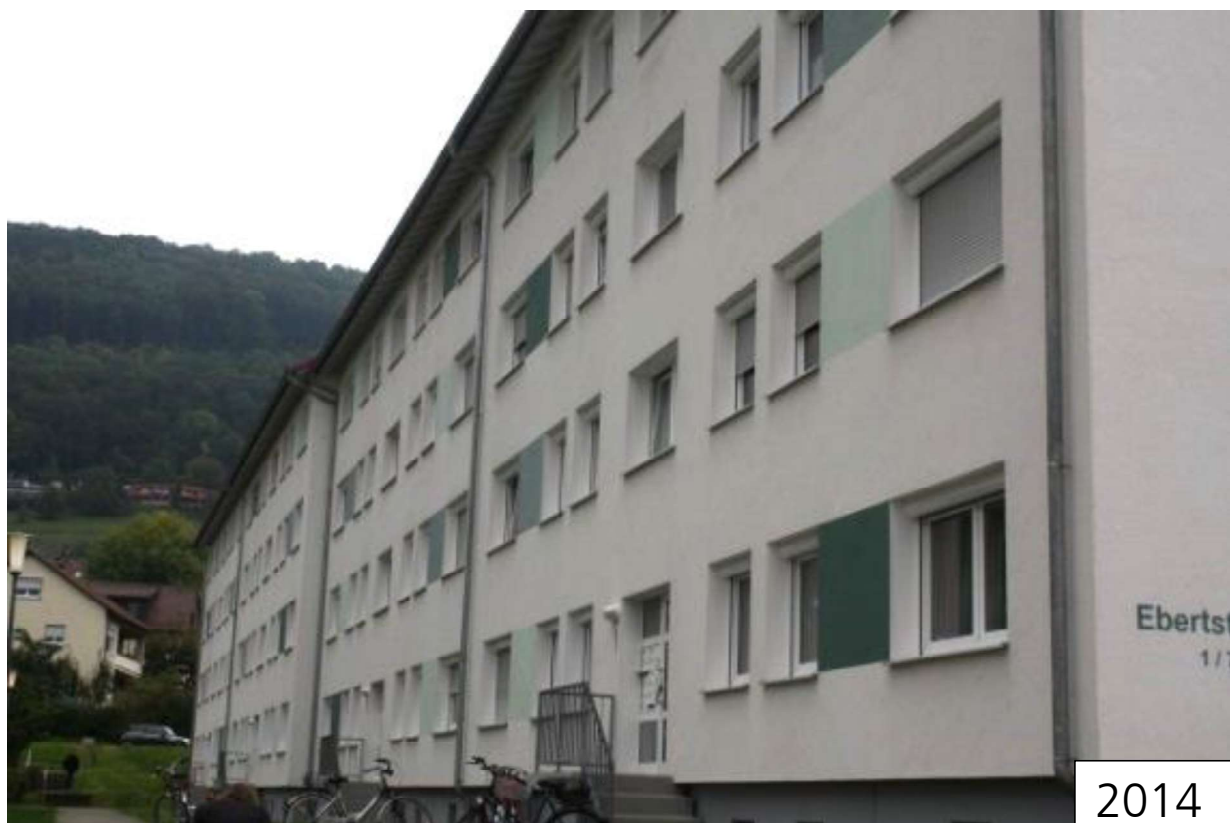
Figure 24:  
View of the north façade of property 32 (Ebertstr. 1–7, Geislingen a. d. Steige)  
in the period between 2004 and 2014.

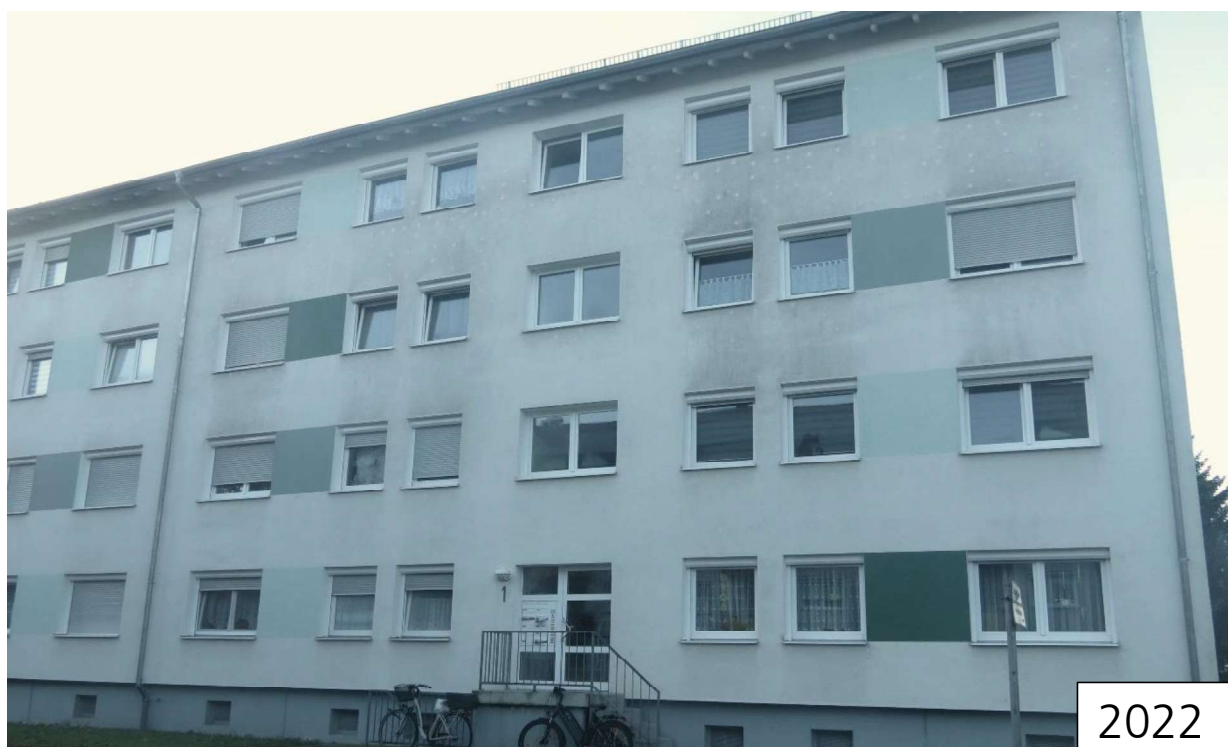
Figure 25:  
View of the north façade of object 32 (Ebertstr. 1–7, Geislingen a. d. Steige) in  
October 2022.

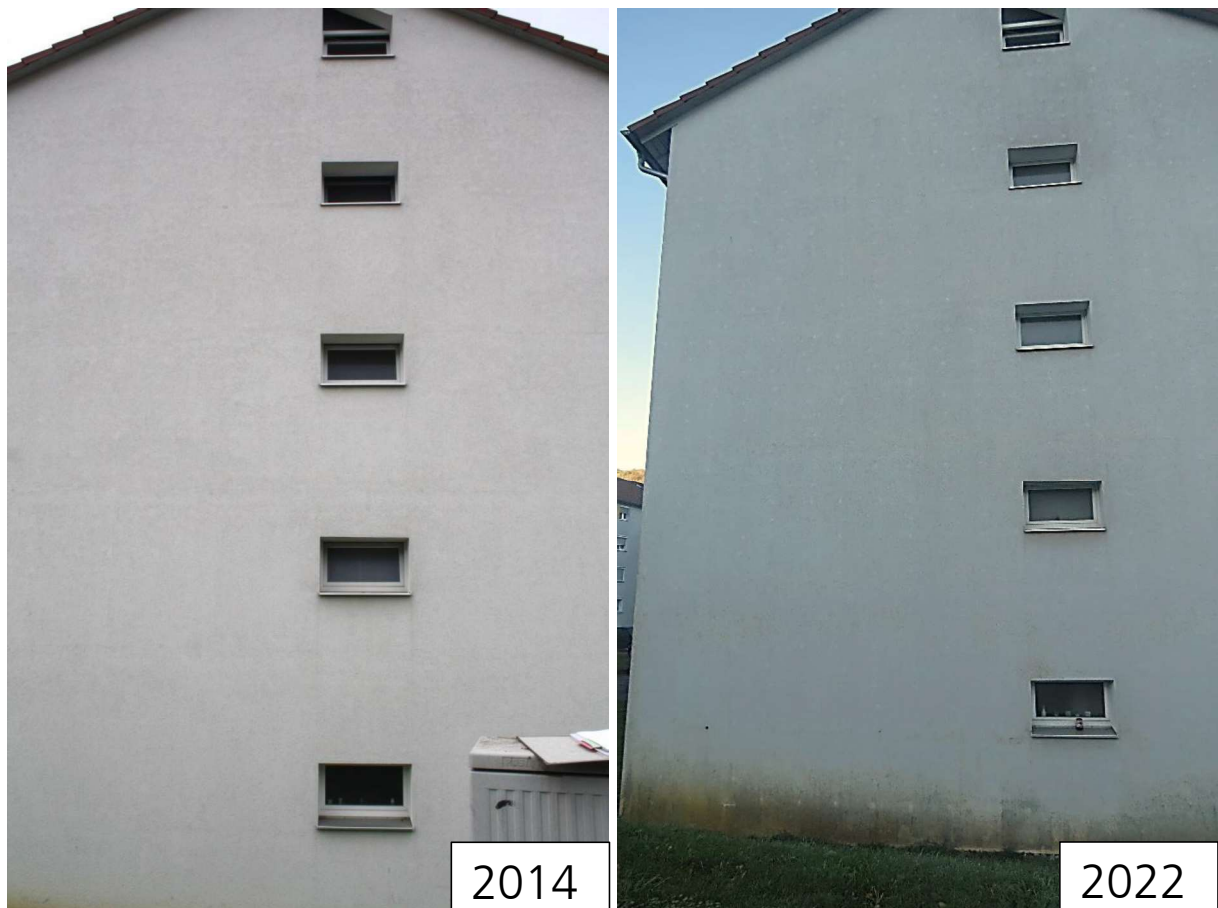
Figure 26:  
East view of the façade of object 32, in 2014 (left) and 2022 (right).

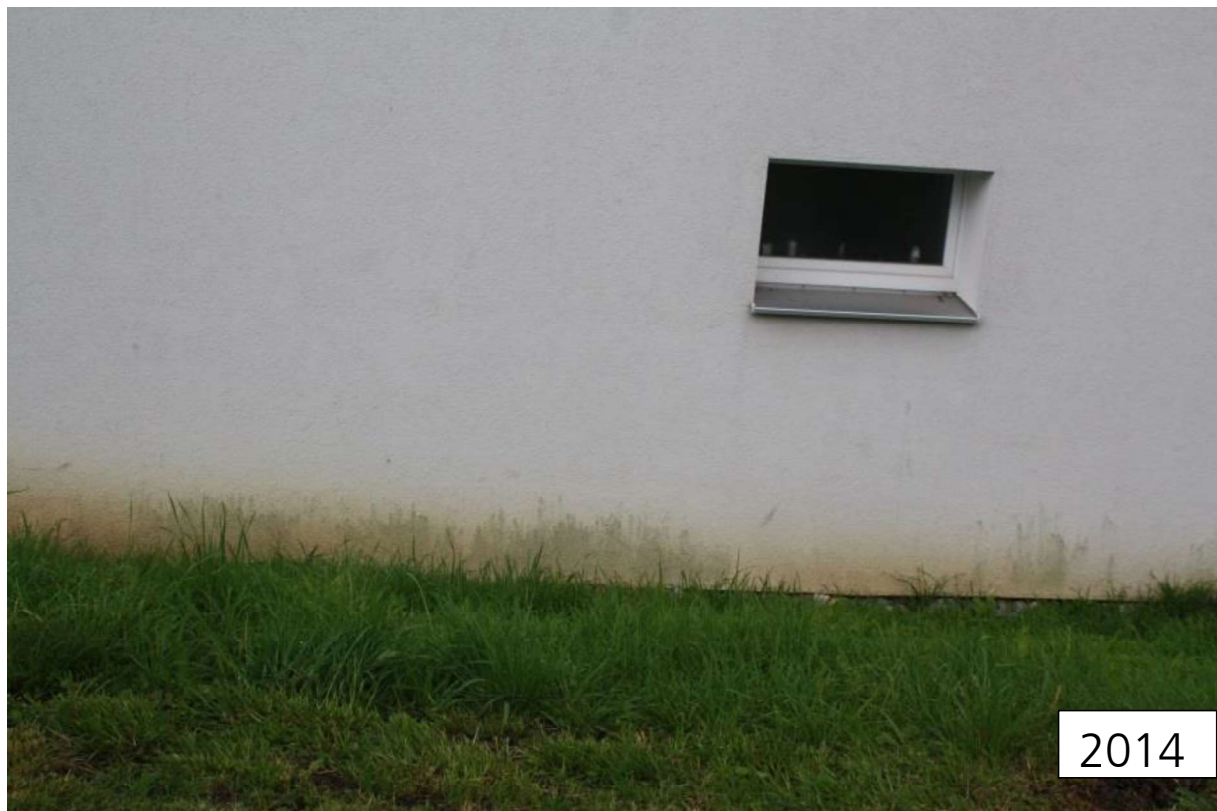
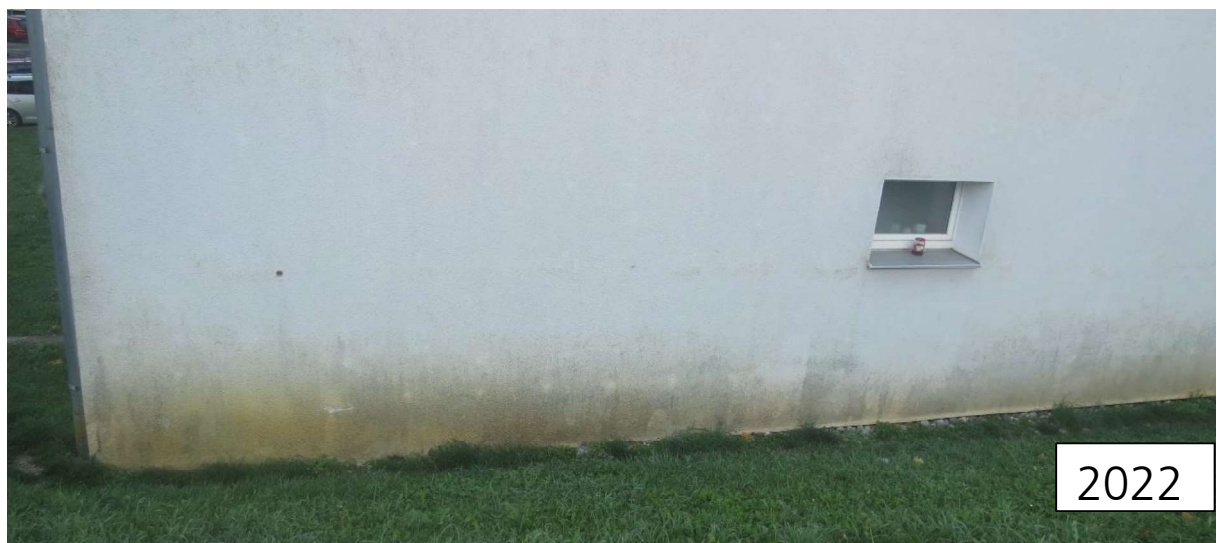
Figure 27:  
View of the lower east façade surface in 2014 (top) and 2022 (bottom) at the connection to the grass strips with noticeable algae growth and soiling of the plaster surface by spray water as well as the appearance of dowel areas.

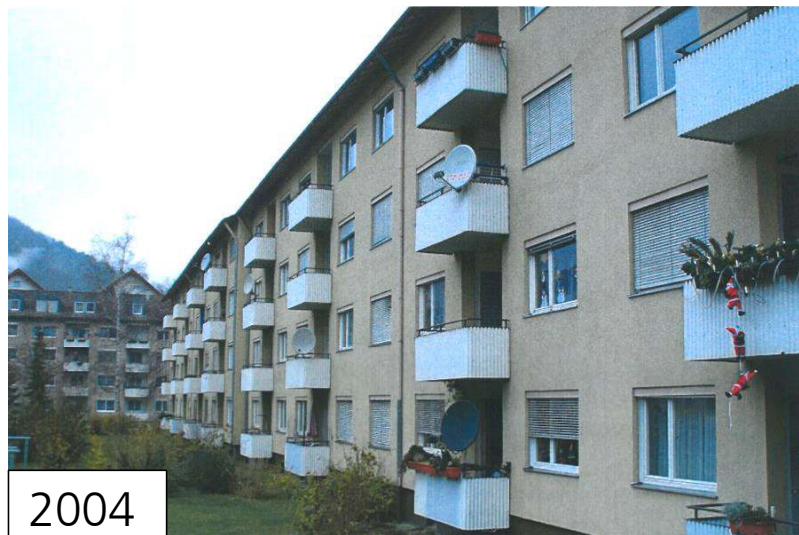
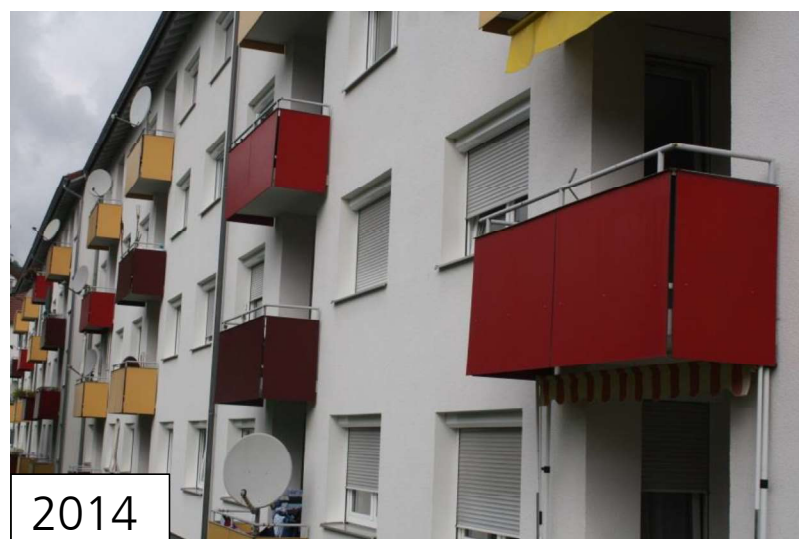
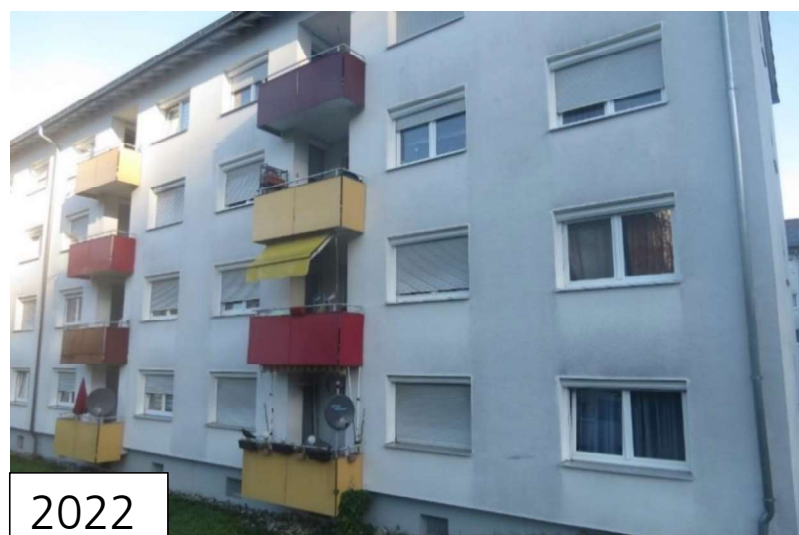
On object 31, no façade renovation measures had been carried out since 2006. Figure 28 shows the south view of the building in 2004, 2014 and 2022. There are no crack formation or blistering defects on this building. Overall, a noticeable graying of the façade is visible mainly in the area between the windows. On the west façade (see Figure 29), extensive graying of the entire façade is visible, but no crack formation.

Figure 28:  
View of the south façades of object 31 (Brüningstr. 2–6, Geislingen a. d. Steige), in 2004 (top), 2014 (center) and 2022 (bottom).

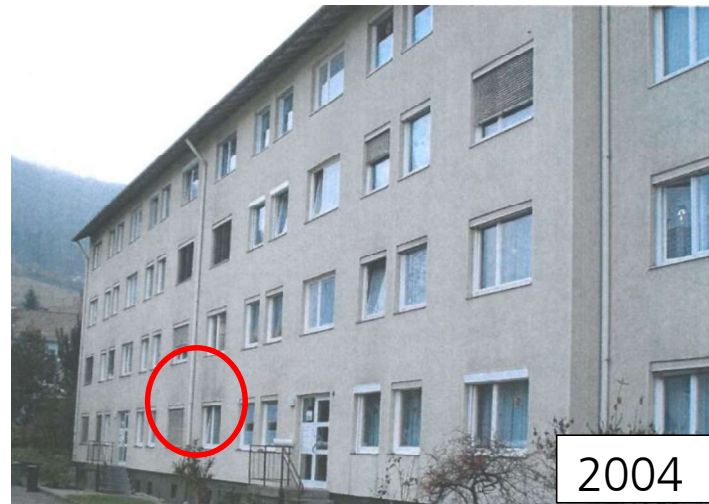
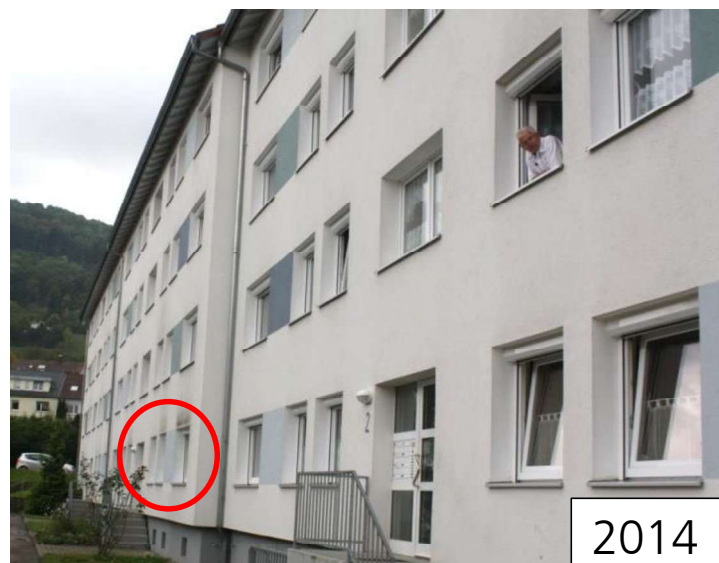
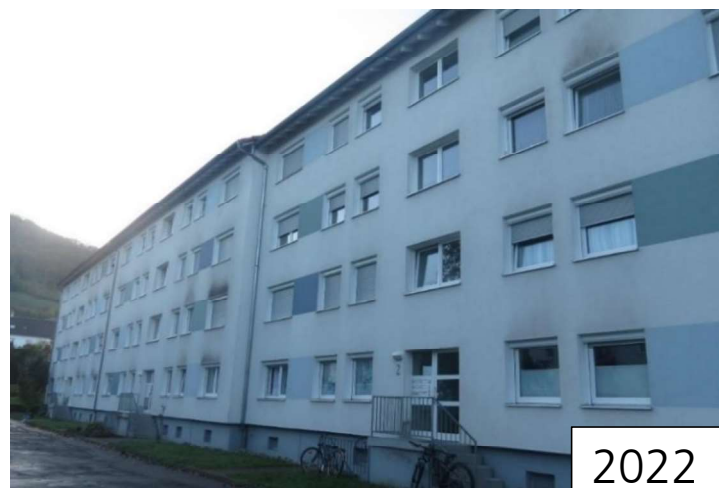
On object 30, no façade renovation measures had been carried out since 2006 either. Figure 30 shows the view of the north façade in 2004, 2014 and 2022. On the façade, the growth of black fungus is seen above the windows on several residential units on the first floor, just like in 2004 and 2014; this is due to windows that had been tilted open for a longer time. Here, moist, warm indoor air flows upwards along the façade and condensate forms because of the cold surface, leading to the formation and growth of black fungus. Except for the usual graying, no defects could be detected on the façade. Another, more noticeable detail can be seen in Figure 31. In 2014, algae growth occurred on the south-west corner of the building, which only appeared on the edge of the building. During the assessment in 2022, there was algae growth on the north-west corner of the building as well as the beginning of algae growth over the surface of the façade. In addition, significant condensation trails were visible in the upper area of the west façade (see Figure 32).

Figure 30:  
View of the north façade of object 30 (Stresemannstr. 2–6, Geislingen a. d. Steige), in 2004 (top), 2014 (center) and 2022 (bottom).

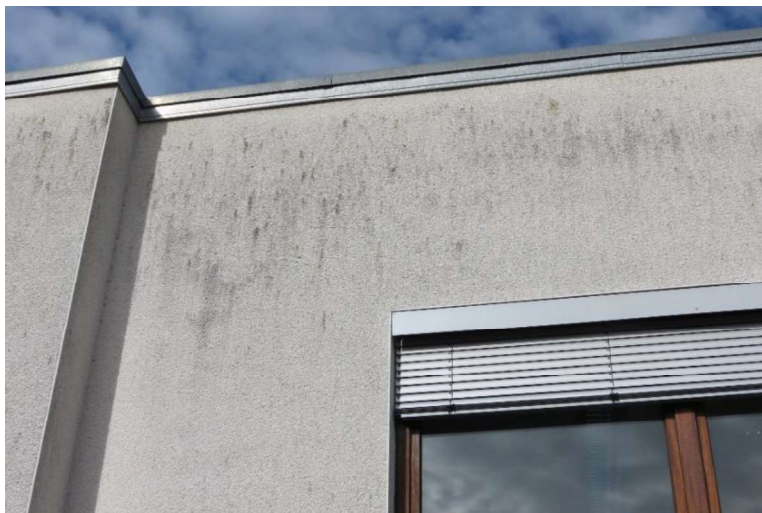
Object 2 is a workshop building that was built in 1973 and insulated in 1986 with 5 cm PUR/PIR insulation and mineral plaster. Since then, the façades have not been renovated anymore. The façade construction was thus 36 years old. No damage is visible over any of the surfaces (see Figure 33). Some damage can be seen only in the base area, although this is likely to have been caused by mechanical influences. Biological growth is also discernible in the lower area of the façade, which is probably due to spray water from the ground. On the south side (Figure 34), noticeable gray areas and condensation trails are visible in the upper façade area.

Figure 34:  
View of the upper south facade.

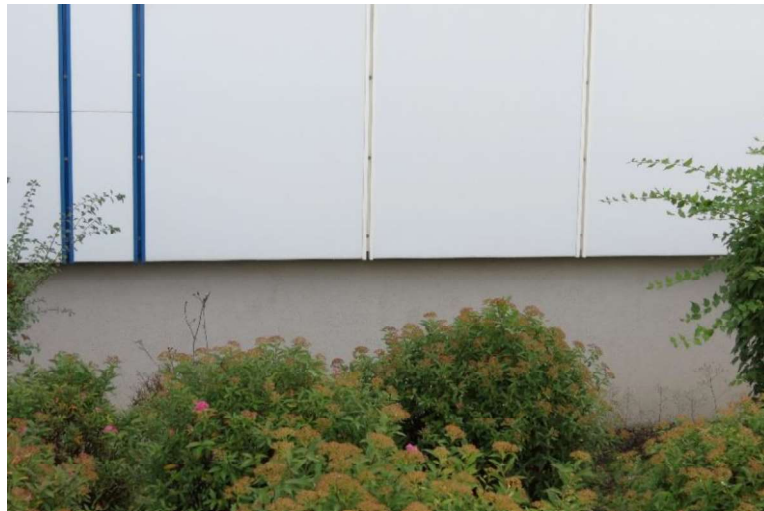
Object 3 is an office building with a base area that was constructed in 1997 with 10 cm of PUR/PIR and a synthetic resin plaster. The façade surfaces on top of this are cladded with façade panels. The assessed surfaces on the north, west and south side of the building (Figure 35 and Figure 36) do not show any biological growth or damage in the base area. Only at the connection of the exterior cellar stairs to the insulated exterior cellar wall (Figure 37) there are significant traces of weathering from rainwater flowing down onto the cellar stairs, but there is no crack formation.

Figure 35:  
View of the base area of the north façade, which is insulated with purenotherm.

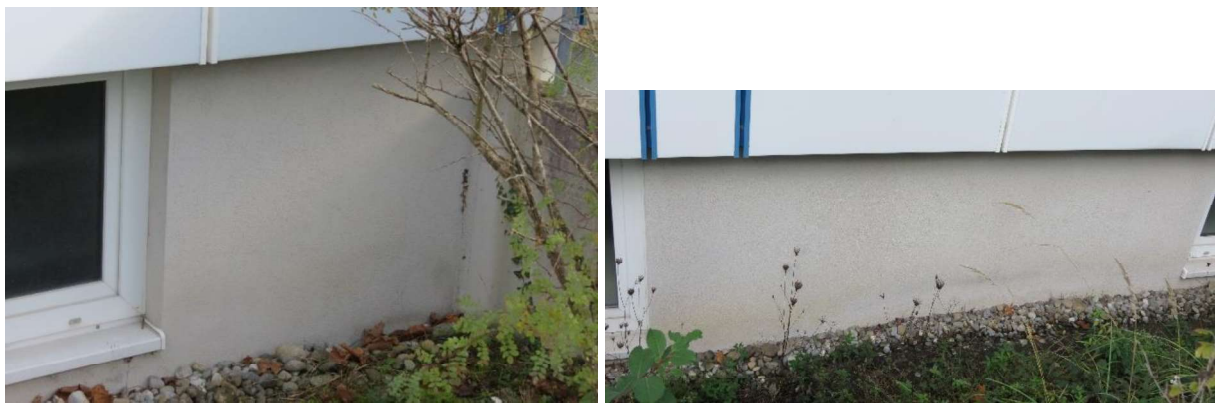
Figure 36:  
View of the base area of the west (left) and south (right) façade, which is insulated with purenotherm.

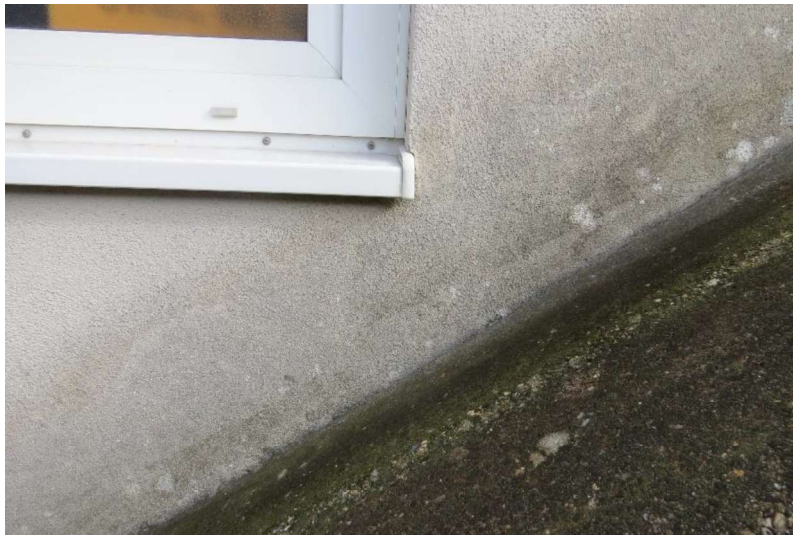
Figure 37:  
View of the base area of the west façade at the stairs going down, which is insulated with purenotherm.

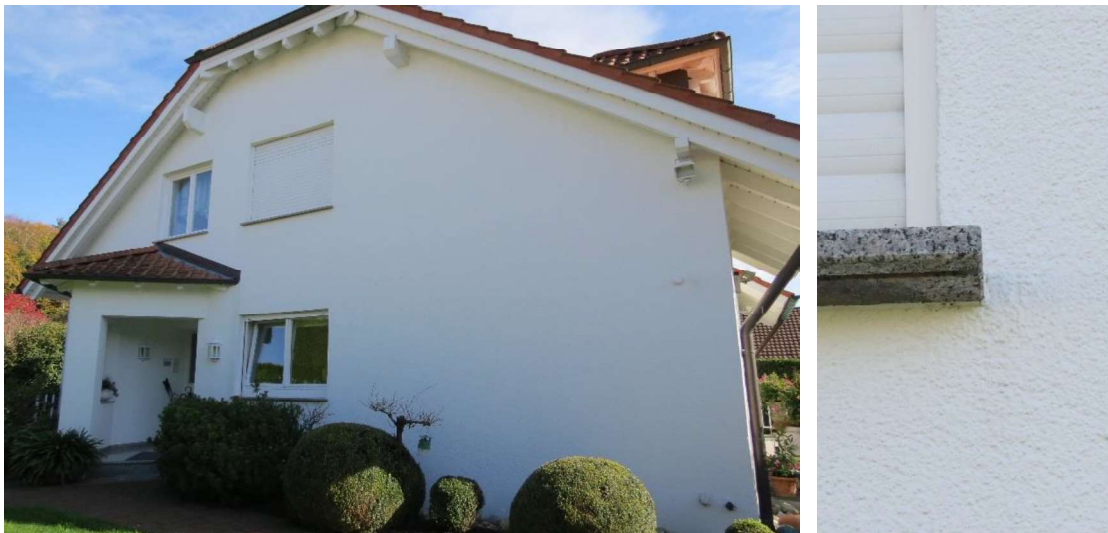
Object 4 is another building with PUR/PIR insulation. This house was built in 1991 and constructed with 8 cm ETICS and synthetic resin plaster. The façades have been painted over once. Figure 38 and Figure 39 show the west and north façade including a windowsill connection. It can be seen here that the façades are in perfect condition. There are no objectionable cracks or graying.

Figure 38:  
View of the west façade (left) and a windowsill connection (right) of object 4.

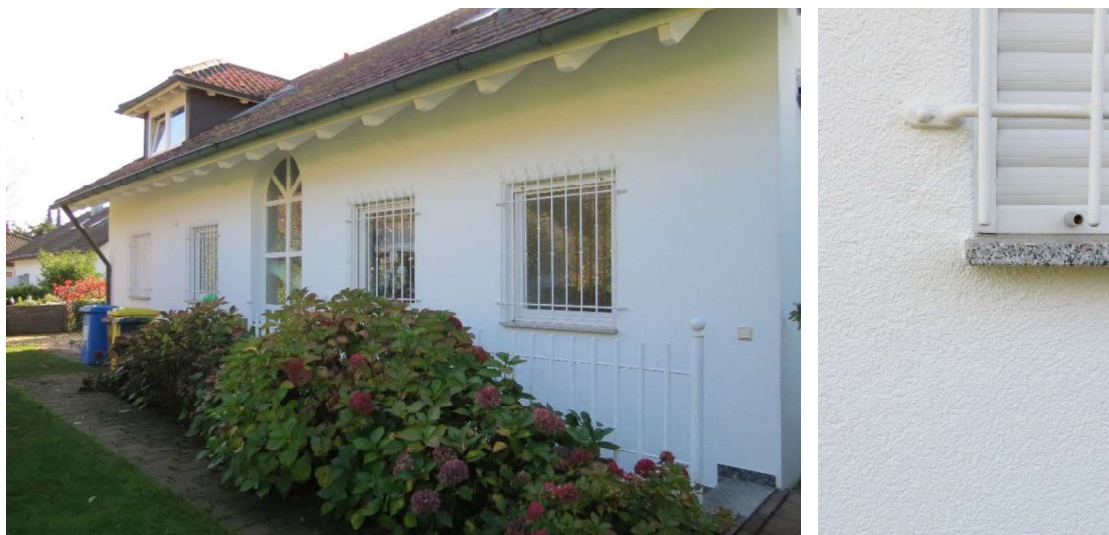
Figure 39:  
View of the north façade (left) and a windowsill connection (right) of object 4.

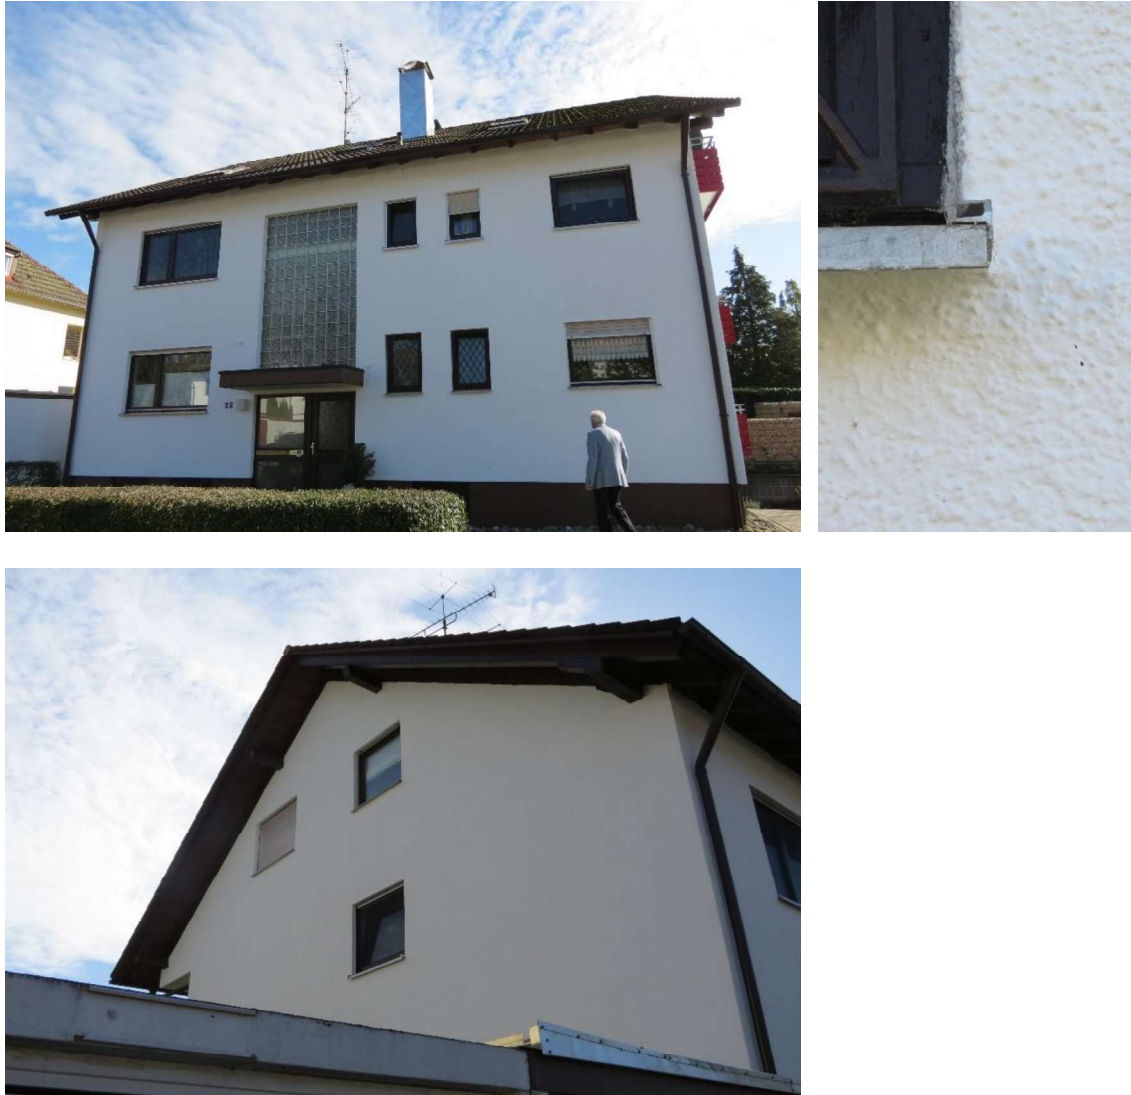
Object 11 was built in 1979/1980 and insulated with an ETICS made of 8 cm PUR/PIR panels. The façades had been painted twice since the building was constructed. The condition of the façades was perfect and free of damage. Views of the west and north façades can be seen in Figure 40.

Figure 40:  
View of object 11 of the west (top left) and north façade (bottom) as well as a windowsill connection on the west side (top right).

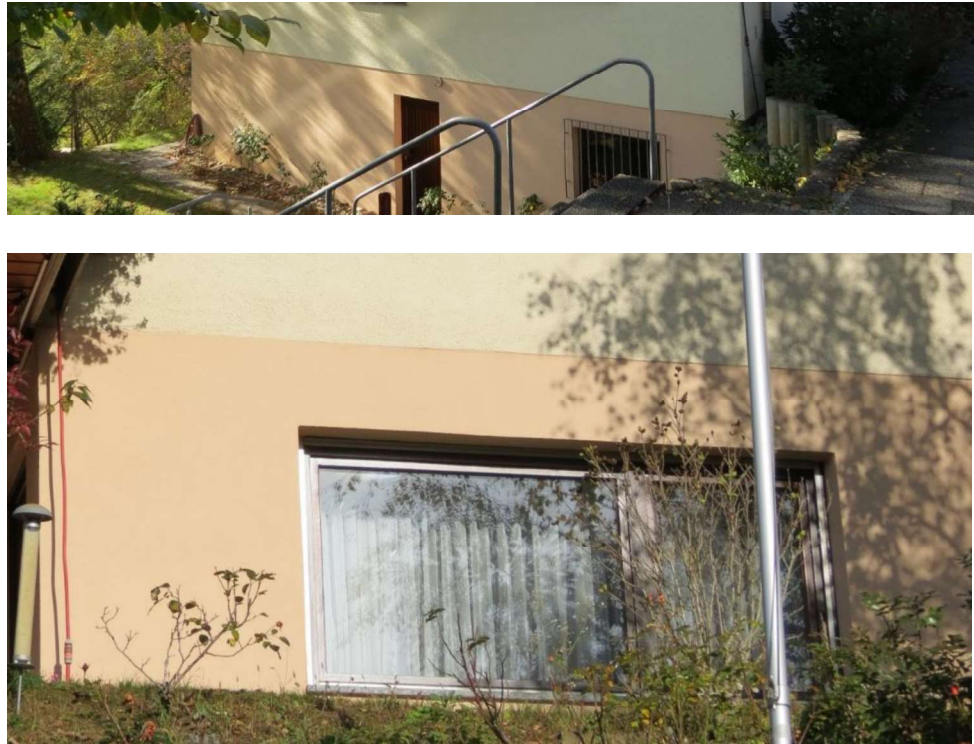
Object 5 is another building with partial insulation. It is a town house built on a slope, and only its east side and its south side on the first floor are insulated with PUR/PIR. Unfortunately, neither the age nor the thickness of the system is known. As can be seen in Figure 41 (orange areas), there is no damage or graying or biological growth on the surfaces.

Figure 41:  
View of the east (top) and south façade (bottom) of object 5.

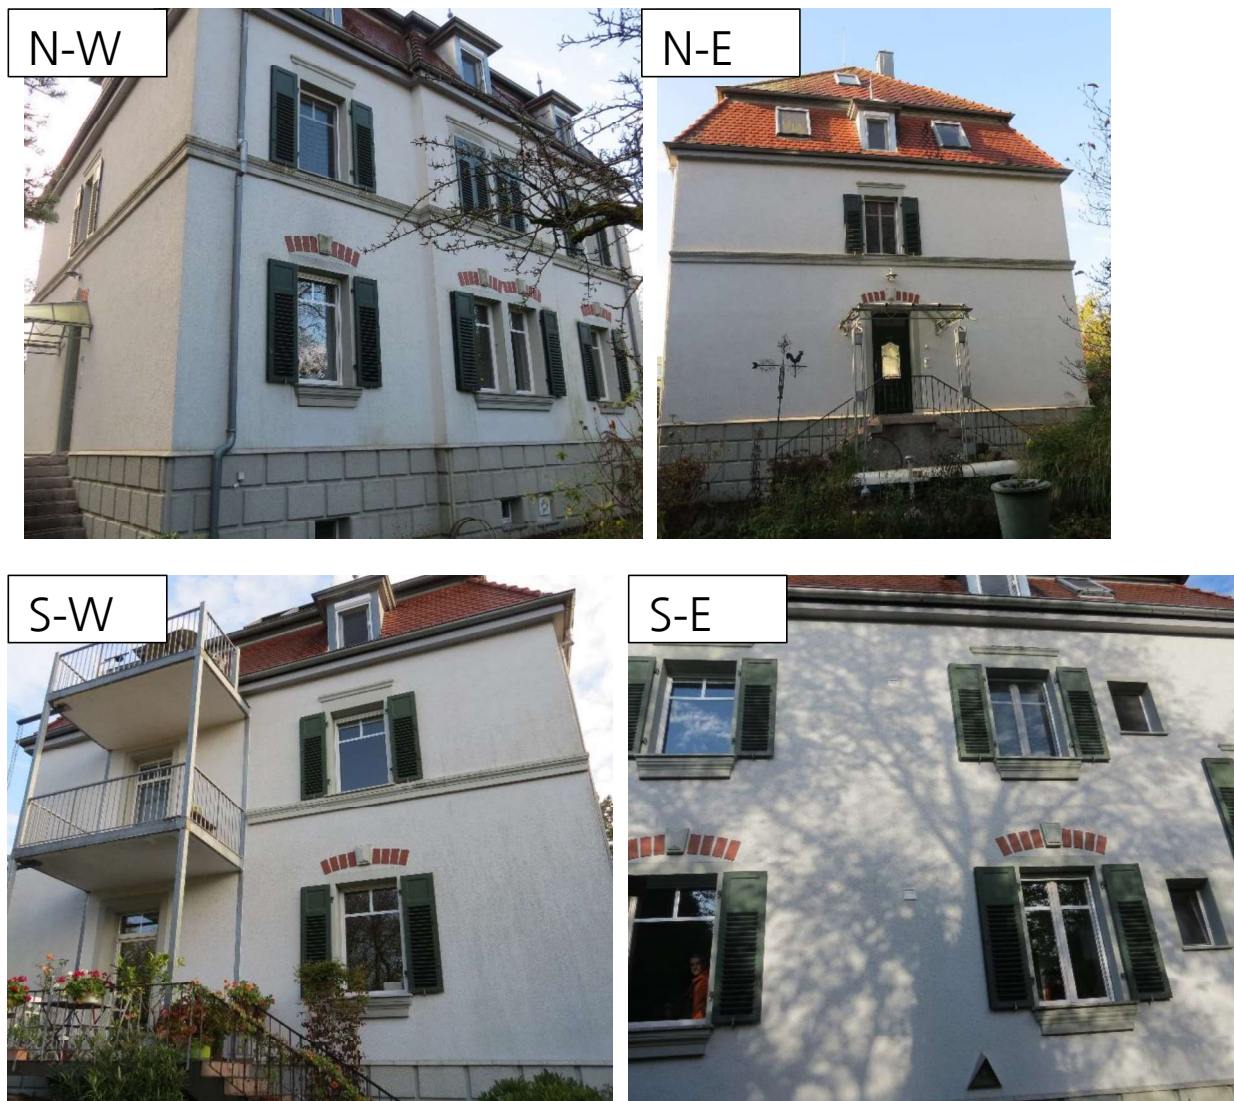
Object 6 is a building that was already built in 1903. In the period of 1996–1998, the façades were completely renovated by removing the old plaster and the cement asbestos panels from the 1960s and replacing them with an ETICS, consisting of 8 cm PUR/PIR panels (without dowels) and a mineral plaster system as well as a silicate coating. During the renovation, façade profiles were applied to restore the original appearance of the house from 1903. Since 1998 there had been no further work on the façades. The façades (Figure 42 to Figure 44) of the house were completely damage-free after 24 years. No cracks, blistering or spalling can be seen. Algae growth and significant graying are visible above all on the north-west and south-west façade of the building. The thick greenery around the house slightly increases the risk of microbial growth on the façades. In addition, growth is visible on the façade profiles and in the connection area of the exterior stairs and the façade, which can be encouraged by spray water in these areas.

View of all four facades of object 6. The building is at a 45° angle to the main orientation. The views are as follows:
