IBP report HTB-005EN/2023

## Assessment of the long-term reliability of installed external thermal insulation composite systems

Conducted on behalf of  
Verband für Dämmsysteme, Putz und Mörtel e.V.  
Reinhardtstraße 14  
10117 Berlin, Germany

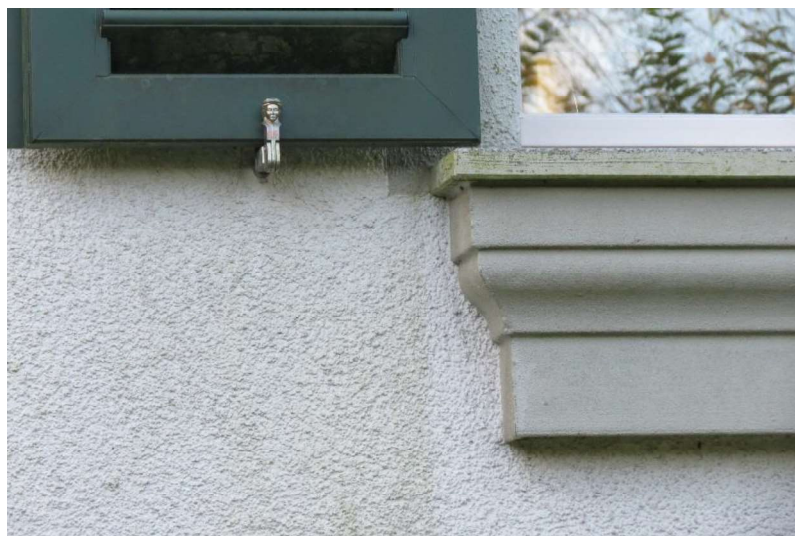
Figure 44:  
Close-up of a window connection with a frieze on the NW façade.

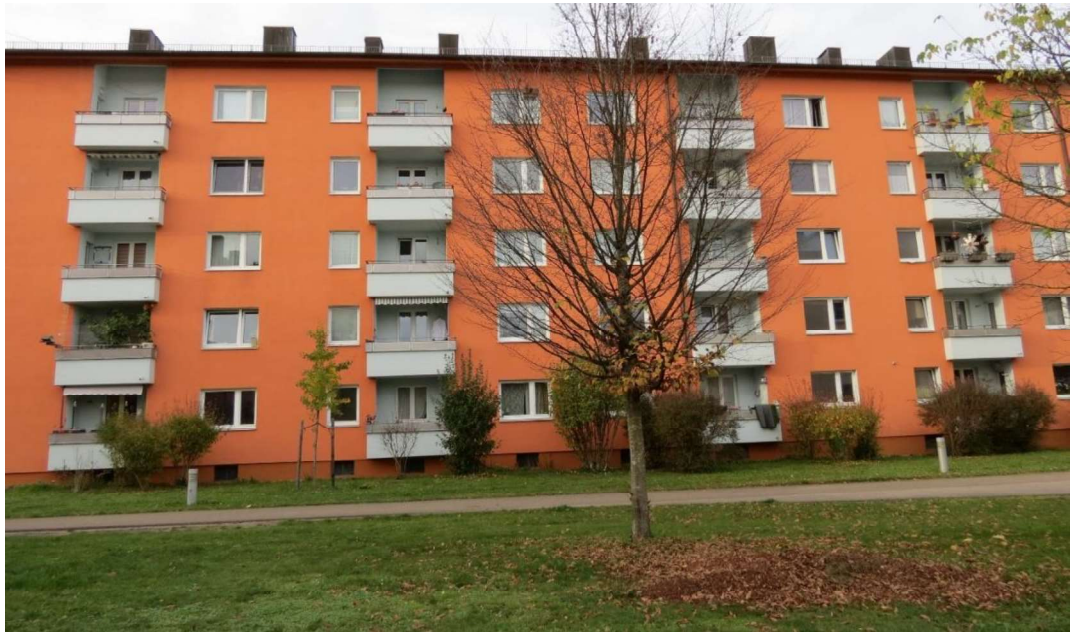
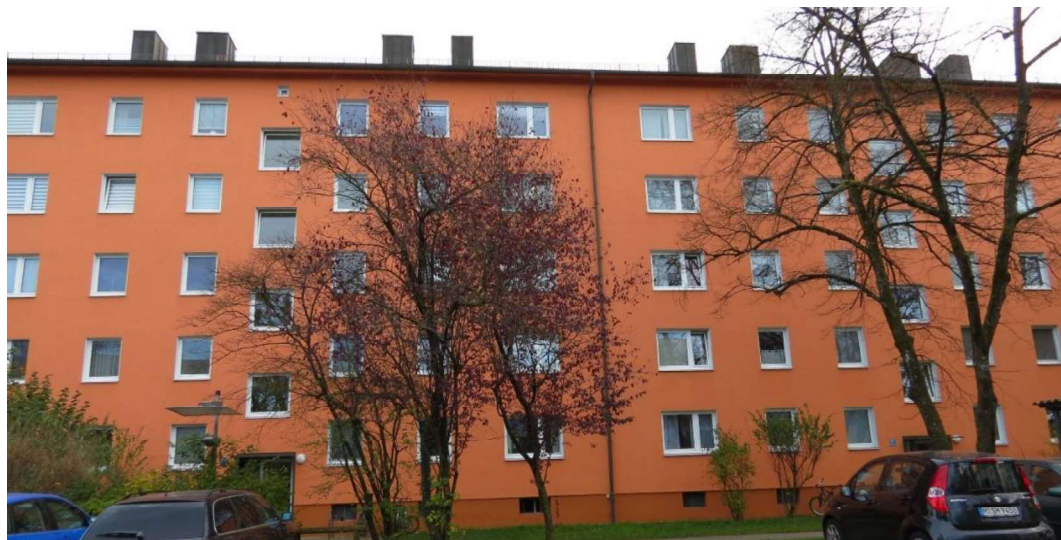
Object 7 consists of four large housing blocks with five stories each (Figure 45 to Figure 49), which were all renovated at the same time. All the buildings were equipped with an ETICS consisting of a 6 cm layer of mineral wool and a 2.5 cm thick layer of plaster in 1987–1988. A renewal coating of silicone resin paint was applied in 2009. The only difference between the buildings is the paint and sometimes the orientation of the building. No crack formation, blistering or spalling of the plaster is visible on any of the buildings. Only on the east side of house number 85 (yellow façade) is there a slight green growth visible on the lower north-east half of the façade, as evident in Figure 48, as well as in a small area on the north side on the first floor (Figure 49).

Figure 45:  
North (bottom) and south view (top) of the house numbers 67–69.

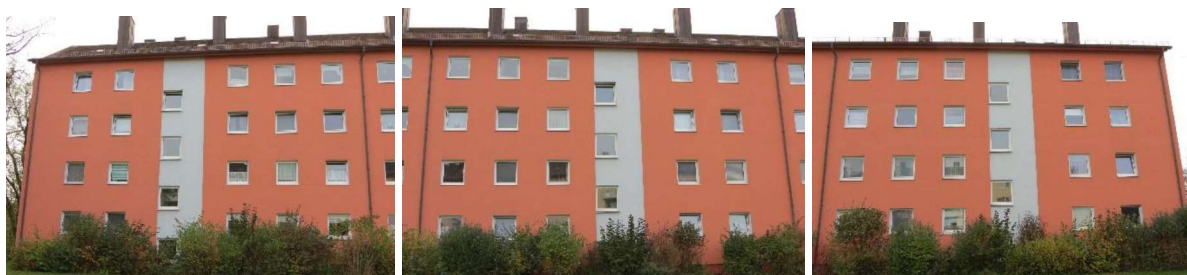
Figure 46:  
East views of the housing block house numbers 73–77.

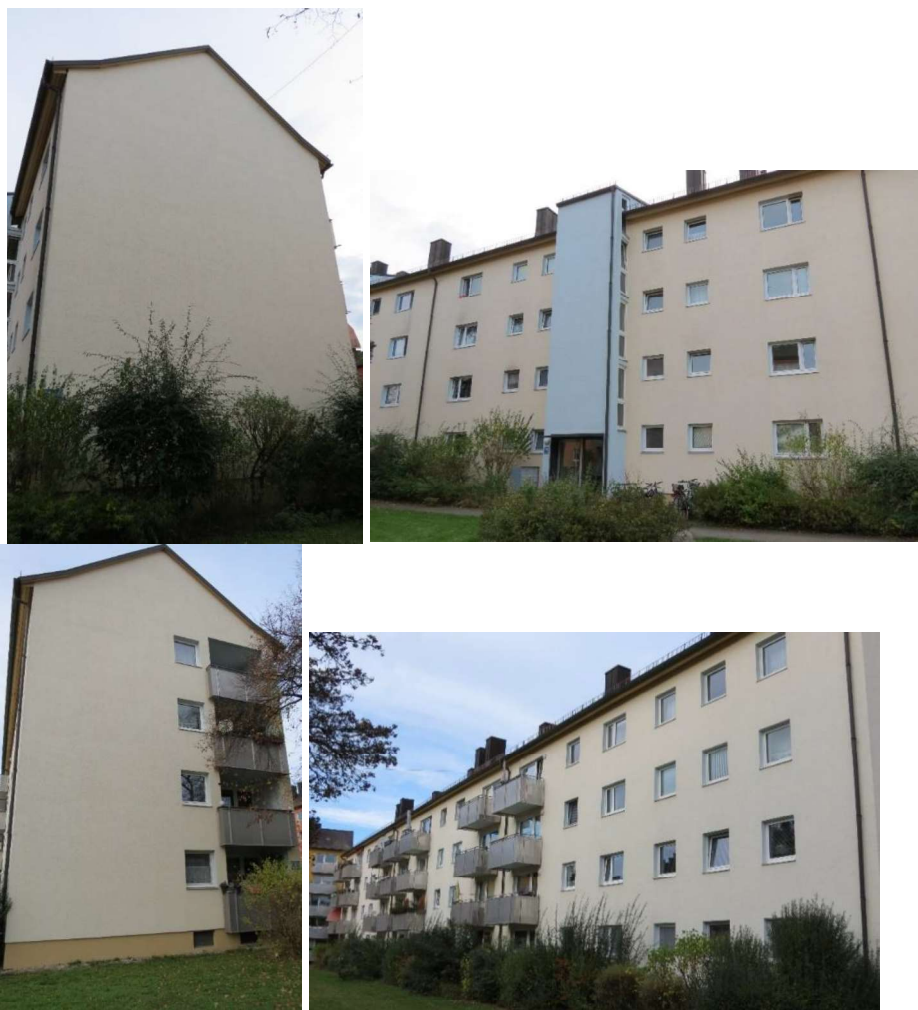
Figure 47:  
Views of the facades of house numbers 79–83.  
Top left: north façade.  
Top right: east façade.  
Bottom left: south façade.  
Bottom right: west façade.

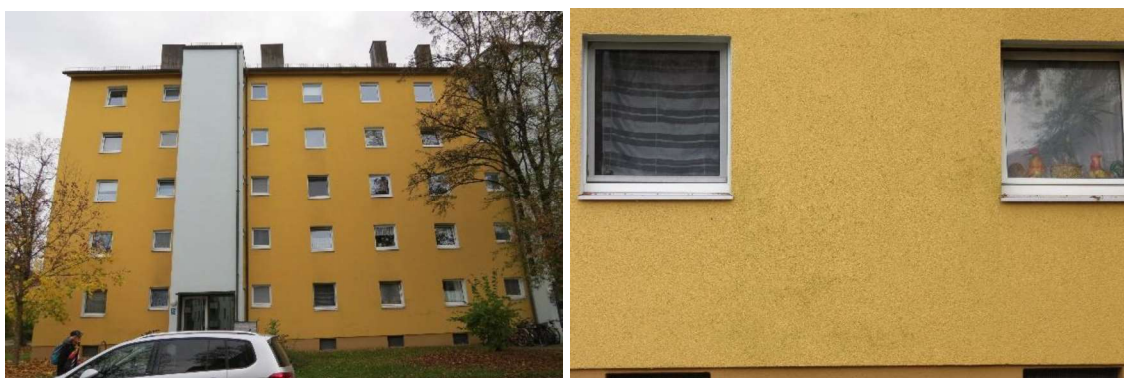
Figure 49:  
View of the north façade of house number 85, including a close-up of the lower façade surface with algae growth.

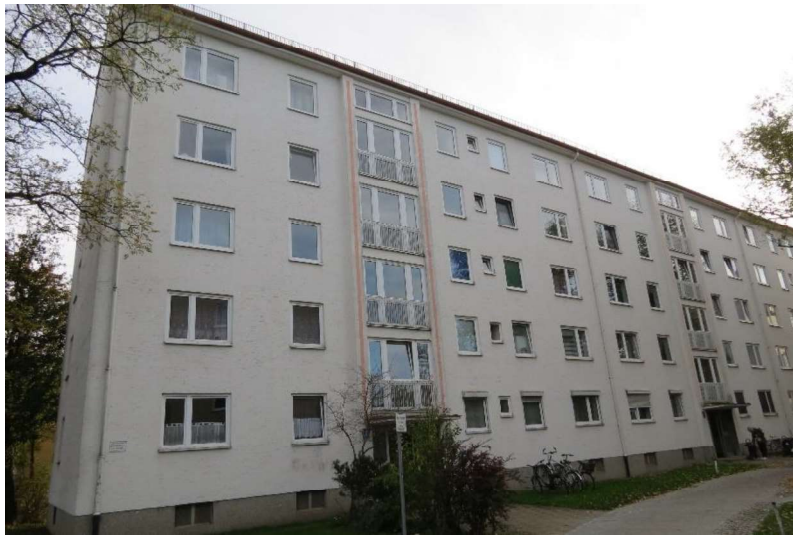
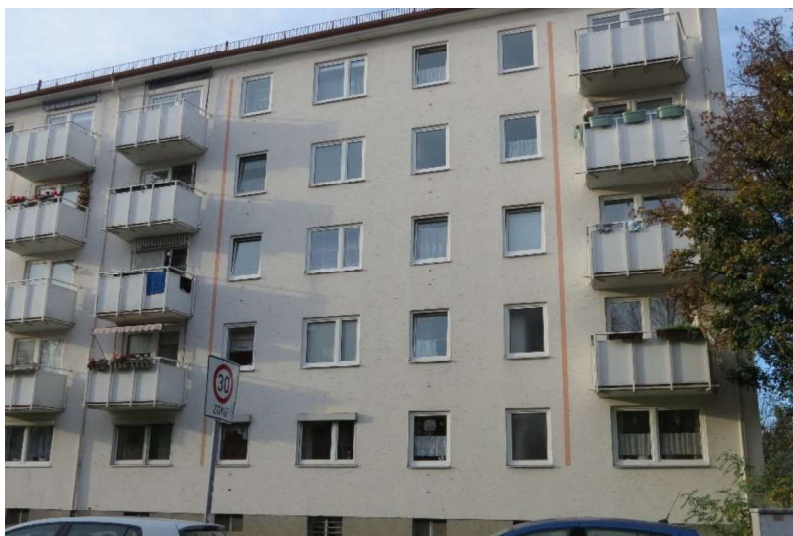
Object 8 (Figure 50) was added to the assessment list; however, upon inspection of the building, it turned out that the building did not have any ETICS yet. Unfortunately, there was no further information on whether and when a new coat of paint was applied to the façade. Optically, there are no irregularities.

Figure 50:  
View of the north (top) and south façade (bottom) of object 8.

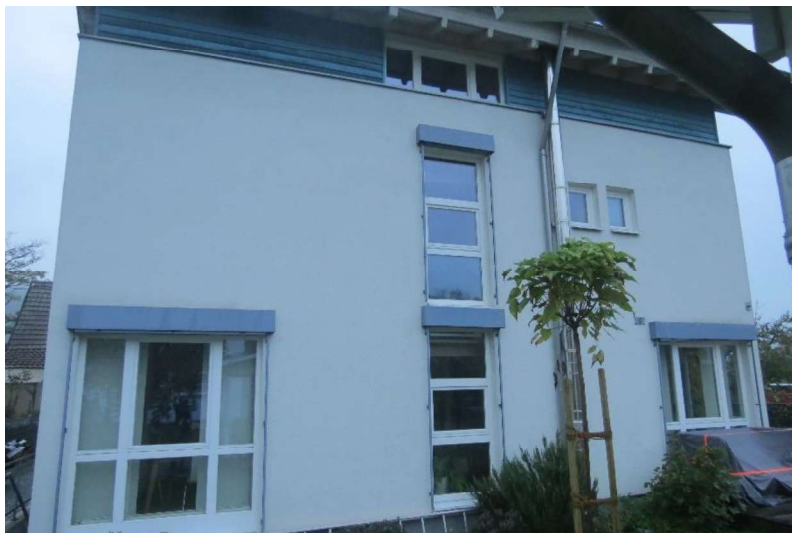
Object 9 is a duplex house where the west side of the building was assessed. The house was built in 1998, insulated with 6 cm wood fiber panels and plastered. The south-west side (Figure 51) of the building shows a slight graying without any features. In the middle of the duplex house, a section of the façade is offset towards the rear. On the south side (Figure 52), the fastening dowels of the ETICS panels appear directly underneath the roof overhang; significant graying of the surface is also visible. On the northwest side, a canopy is mounted in the recess of the building. In the area of the center fastening of the steel construction (Figure 53), cracks have formed over the plaster, which are related to the load transfer of the structure, though. Otherwise, no cracks are visible on any of the three house façade surfaces.

Figure 51:  
View of the south-west façade of object 9.

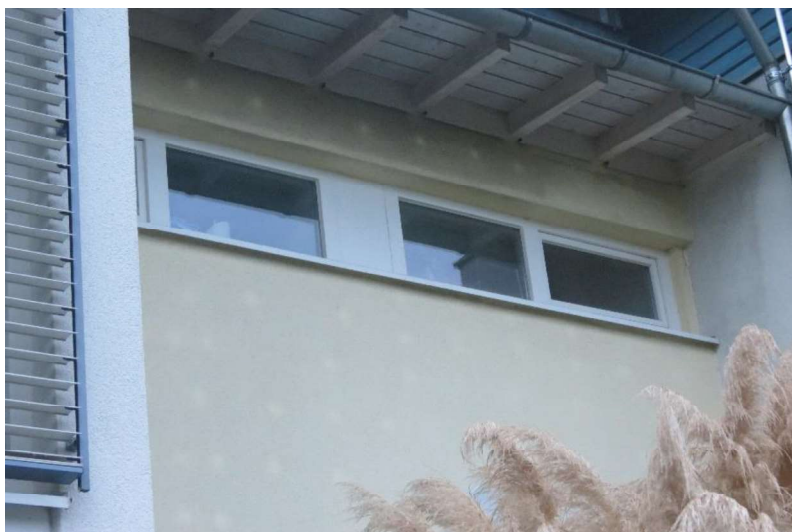
Figure 52:  
View of the south-east façade of object 9, which is offset to the rear.

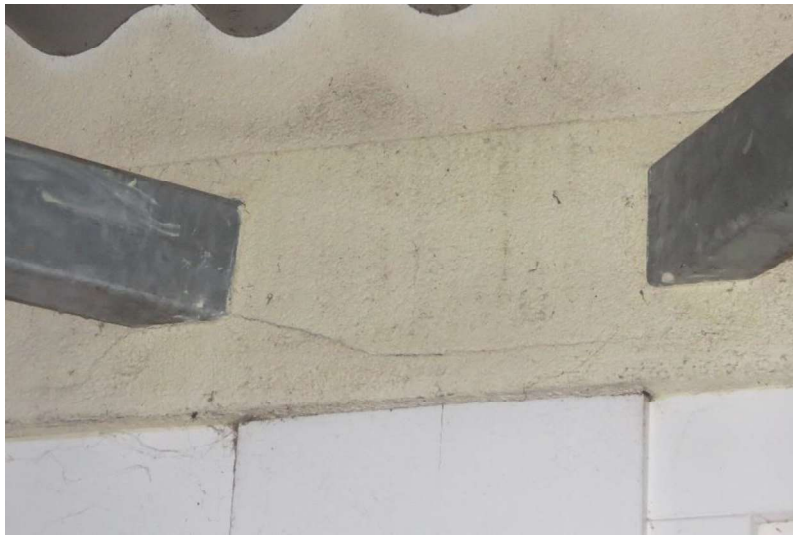
Figure 53:  
Connection detail of the canopy on the north-west side of object 9.

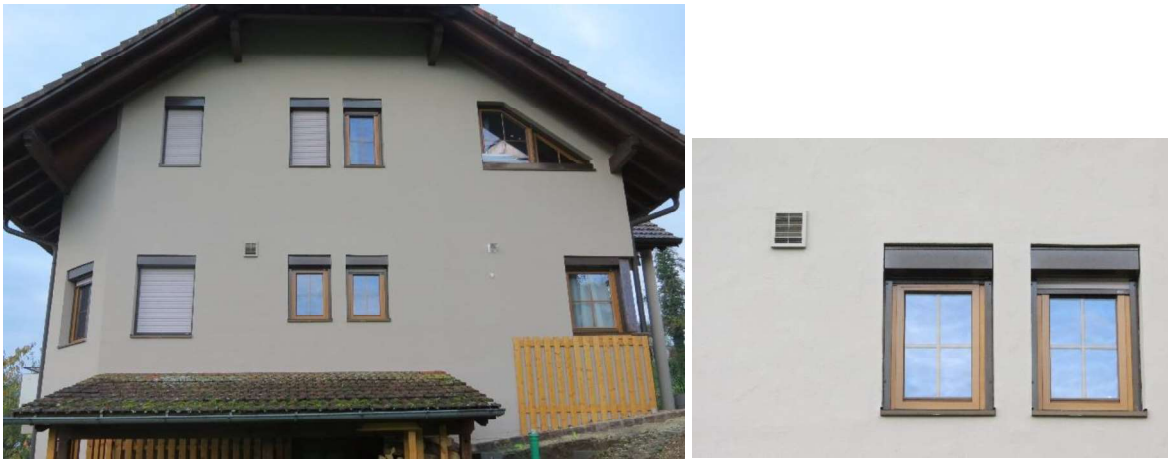
Figure 55:  
View of the north façade of object 9 with close-up of the ventilation opening next to the windows.

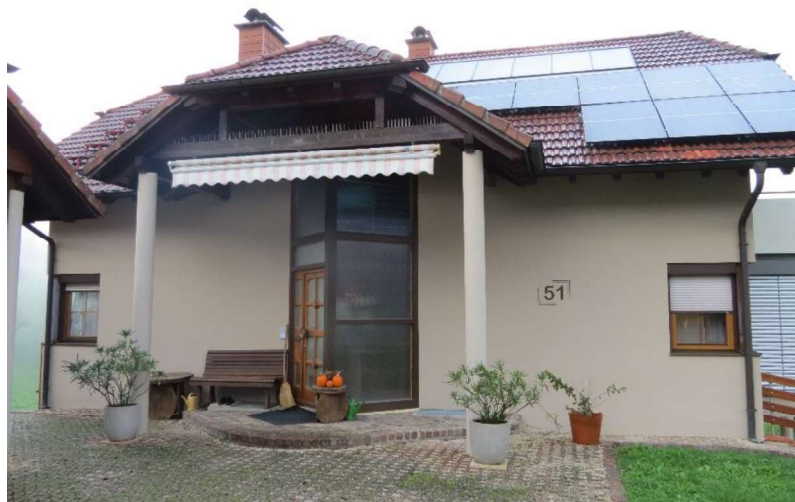
Figure 56:  
View of the west façade of object 9
